General Information

Make	Mitsubishi	Model	Mirage
YOM	2023	Odo Meter Reading	91,175
Registration No.	NEE8788	Chassis No.	PAEA13TJPNA003001
CC	1.2	Transmission	A/T
Fuel Type	Gas	Type of Body	Sedan
Colour	Silver

Body / Panel Condition

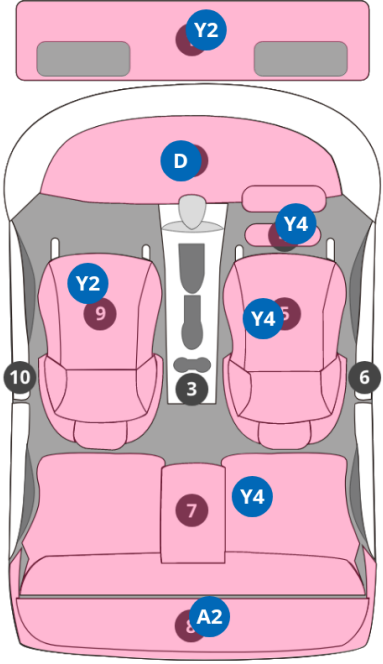
Interior Evaluation : C	Exterior Evaluation : E

<p>a : Cut, Fray d : Loose, Deformed k : Animal Hair s : Smell t : Cigarette Burns x : Defective y : Stain</p>

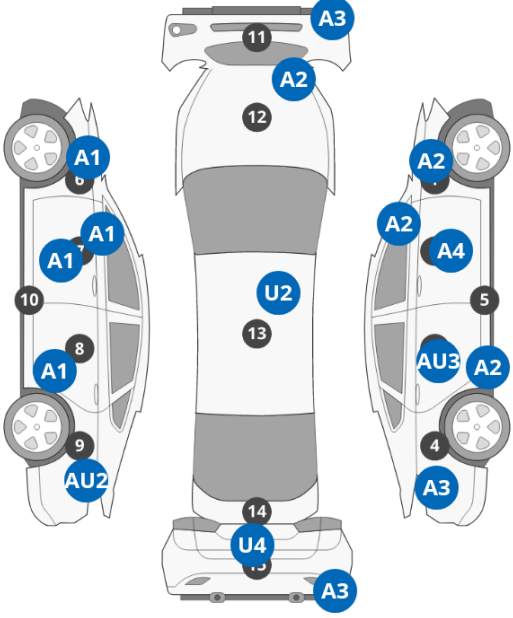
<p>A : Scratch AU : Scratch & Dent B : Modified C : Corrosion G : Stone chip P : Faded S : Rust SC : Rust & Corrosion U : Dent X : Defective Y : Crack, Gap</p>
<p>Remarks Trunk Room - Worn, Scratch, Cut, Crack - Small / Rear Seat - Grime - Large / (R) Front Seat - Grime - Large / (L) Front Seat - Grime - Small / (L) Front Floor Mat - Grime - Large / Ceiling - Grime - Small / Dashboard - Traces of Adhesive Tape - Yes</p>	<p>Remarks Trunk Hood, Rear Gate - Dent - Large / (L) Rear Fender, Molding - Scratch & Dent - Small / Rear Bumper, Lamps, Panels - Scratch - Medium / (R) Rear Fender, Molding - Scratch - Medium / (R) Rear Door, Molding - Scratch & Dent - Medium / (R) Front Door, Molding - Scratch - Large / (R) Step, In-panel, Side Spoiler - Scratch - Small / (R) Front Fender, Molding - Scratch - Small / (R) Mirror - Scratch - Small / Roof - Dent - Small / Front Bumper, Grille, Lamps - Scratch - Medium / Bonnet, Headlight - Scratch - Small / (L) Mirror - Scratch - Minimal / (L) Front Fender, Molding - Scratch - Minimal / (L) Front Door, Molding - Scratch - Minimal / (L) Rear Door, Molding - Scratch - Minimal</p>
