General Information

Make	Mitsubishi	Model	Mirage
YOM	2023	Odo Meter Reading	19,652
Registration No.	NFB3094	Chassis No.	PAEA13PRXPPA015613
CC	1.2	Transmission	CVT
Fuel Type	Gas	Type of Body	Sedan
Colour	Gray

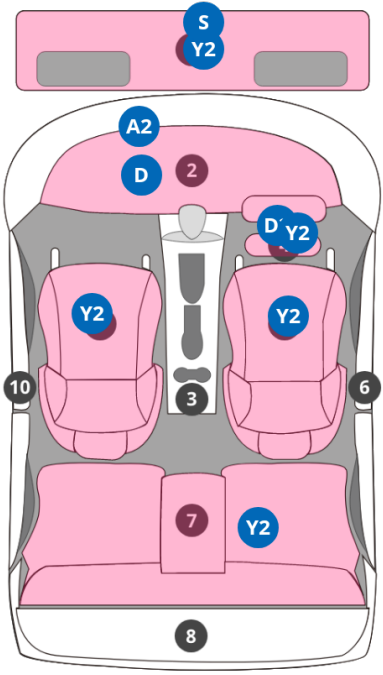
Interior Evaluation : B	Exterior Evaluation : E

<p>a : Cut, Fray d : Loose, Deformed k : Animal Hair s : Smell t : Cigarette Burns x : Defective y : Stain</p>

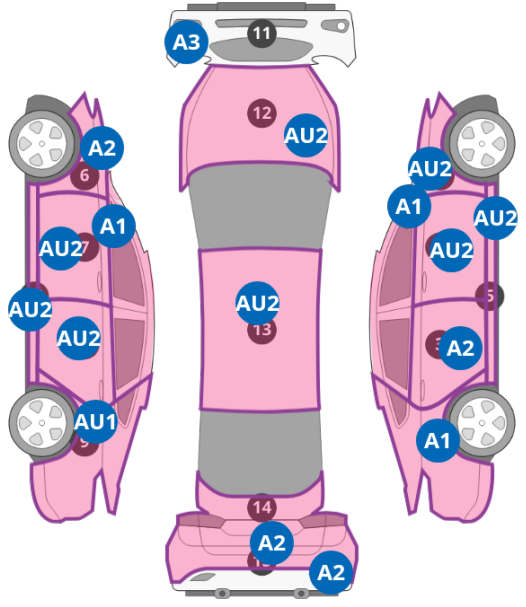
<p>A : Scratch AU : Scratch & Dent B : Modified C : Corrosion G : Stone chip P : Faded S : Rust SC : Rust & Corrosion U : Dent X : Defective Y : Crack, Gap</p>
<p>Remarks (L) Front Floor Mat - Worked - Small / Dashboard - Traces of Adhesive Tape - Yes / Dashboard - Worn, Scratch, Cut, Crack - Small / (L) Front Seat - Grime - Small / (R) Front Seat - Grime - Small / Rear Seat - Grime - Small / Mat Other - Grime - Small / Ceiling - Grime - Small / Overall Interior - Smell - Yes</p>	<p>Remarks (R) Front Door - Repair Traces - Yes / (R) Step - Repair Traces - Yes / (R) Front Fender - Repair Traces - Yes / Bonnet - Repair Traces - Yes / (L) Front Fender - Repair Traces - Yes / (L) Front Door - Repair Traces - Yes / (L) Step - Repair Traces - Yes / (R) Step, In-panel, Side Spoiler - Repair mark - Yes / (L) Step, In-panel, Side Spoiler - Repair mark - Yes / (L) Front Fender, Molding - Repair mark - Yes / (L) Front Door, Molding - Repair mark - Yes / (R) Front Door, Molding - Repair mark - Yes / (R) Front Fender, Molding - Repair mark - Yes / Bonnet, Headlight - Repair mark - Yes / (L) Rear Fender, Molding - Repair mark - Yes / (R) Rear Fender, Molding - Repair mark - Yes / (R) Rear Door, Molding - Repair mark - Yes / Overall Exterior - Full Re-Paint in same color - Yes / (L) Rear Door, Molding - Repair mark - Yes / Trunk Hood, Rear Gate - Repair mark - Yes / Roof - Repair mark - Yes / Front Bumper, Grille, Lamps - Scratch - Medium / (L) Front Fender, Molding - Scratch - Small / (L) Front Door, Molding - Scratch & Dent - Small / (L) Rear Door, Molding - Scratch & Dent - Small / (L) Step, In-panel, Side Spoiler - Scratch & Dent - Small / (L) Rear Fender, Molding - Scratch & Dent - Minimal / Bonnet, Headlight - Scratch & Dent - Small / (L) Mirror - Scratch - Minimal / Trunk Hood, Rear Gate - Scratch - Small / Rear Bumper, Lamps, Panels - Scratch - Small / (R) Rear Fender, Molding - Scratch - Minimal / (R) Rear Door, Molding - Scratch - Small / (R) Front Door, Molding - Scratch & Dent - Small / (R) Step, In-panel, Side Spoiler - Scratch & Dent - Small / (R) Front Fender, Molding - Scratch & Dent - Small / (R) Mirror - Scratch - Minimal / Roof - Scratch & Dent - Small</p>
