General Information

Make	Toyota	Model	Vios
YOM	2022	Odo Meter Reading	43,187
Registration No.	CBD2904	Chassis No.	PA1B18F30N4177500
CC	1.3	Transmission	CVT
Fuel Type	Gas	Type of Body	Sedan
Colour	Green

Body / Panel Condition

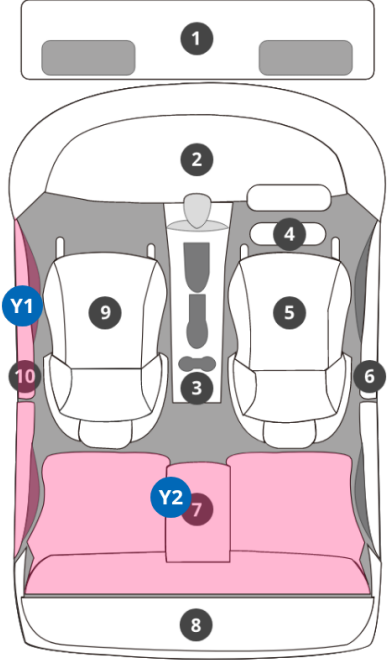
<p>a : Cut, Fray d : Loose, Deformed k : Animal Hair s : Smell t : Cigarette Burns x : Defective y : Stain</p>

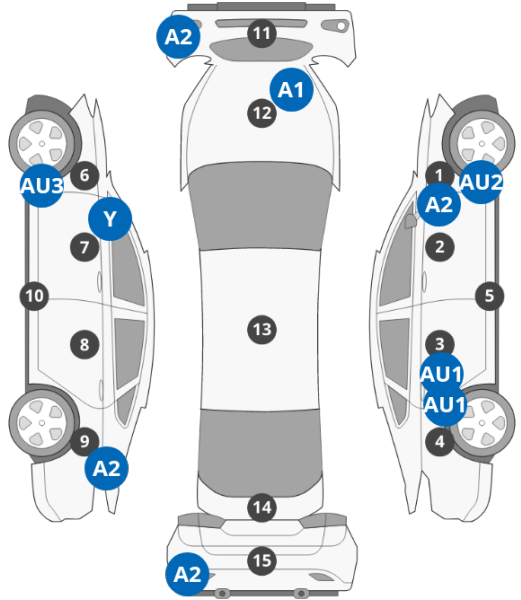
<p>A : Scratch AU : Scratch & Dent B : Modified C : Corrosion G : Stone chip P : Faded S : Rust SC : Rust & Corrosion U : Dent X : Defective Y : Crack, Gap</p>
<p>Remarks Rear Seat - Grime - Small / (L) Front Trim - Grime - Minimal</p>	<p>Remarks (L) Front Fender - Repair Traces - Yes / (L) Rear Fender - Repair Traces - Yes / (R) Front Door, Molding - Scratch - Small / (R) Rear Door, Molding - Scratch & Dent - Minimal / (R) Rear Fender, Molding - Scratch & Dent - Minimal / Rear Bumper, Lamps, Panels - Scratch - Small / (L) Rear Fender, Molding - Scratch - Small / (L) Mirror - Crack - Damaged / (L) Front Fender, Molding - Scratch & Dent - Medium / (R) Front Fender, Molding - Scratch & Dent - Small / Bonnet, Headlight - Scratch - Minimal / Front Bumper, Grille, Lamps - Scratch - Small</p>
