General Information

Make	Toyota	Model	Vios
YOM	2024	Odo Meter Reading	27,508
Registration No.	CCD3770	Chassis No.	PA1B18F33R4254026
CC	1.3	Transmission	CVT
Fuel Type	Gas	Type of Body	Sedan
Colour	Black

Body / Panel Condition

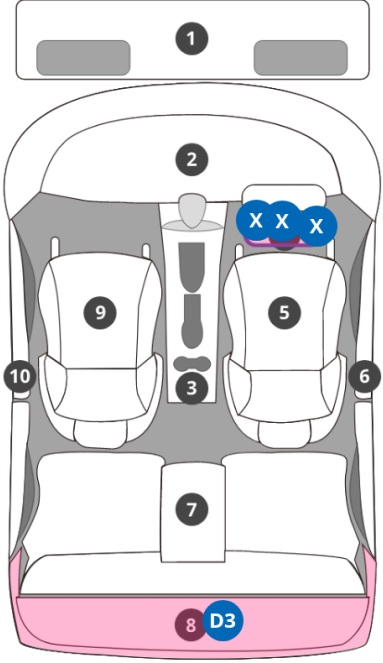
Interior Evaluation : B	Exterior Evaluation : C

<p>a : Cut, Fray d : Loose, Deformed k : Animal Hair s : Smell t : Cigarette Burns x : Defective y : Stain</p>

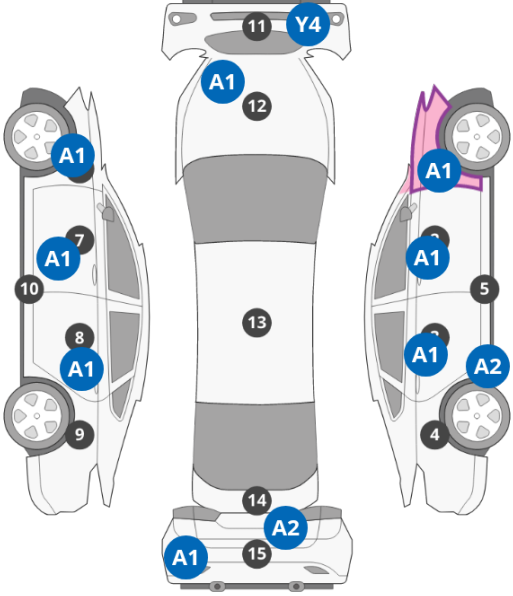
<p>A : Scratch AU : Scratch & Dent B : Modified C : Corrosion G : Stone chip P : Faded S : Rust SC : Rust & Corrosion U : Dent X : Defective Y : Crack, Gap</p>
<p>Remarks (R) Front Floor Mat - Missing - Yes / (L) Front Floor Mat - Missing - Yes / Mat Other - Missing - Yes / Trunk Room - Loose, Deformed - Medium</p>	<p>Remarks (R) Front Door - Repair Traces - Yes / (R) Front Fender - Repair Traces - Yes / (R) Front Fender, Molding - Repair mark - Yes / (R) Front Fender, Molding - Scratch - Minimal / (R) Step, In-panel, Side Spoiler - Scratch - Small / (R) Rear Door, Molding - Scratch - Minimal / (R) Front Door, Molding - Scratch - Minimal / Rear Bumper, Lamps, Panels - Scratch - Minimal / Trunk Hood, Rear Gate - Scratch - Small / (L) Rear Door, Molding - Scratch - Minimal / (L) Front Door, Molding - Scratch - Minimal / (L) Front Fender, Molding - Scratch - Minimal / Front Bumper, Grille, Lamps - Crack, Gap - Large / Bonnet, Headlight - Scratch - Minimal</p>

<p>Inspector Notes</p>
<p>With Lto plate, 2keys, no warranty booklet, no jack and tools, no spare tire, scratches on headlight and taillight, traces of adhesive on vehicle</p>
