General Information

Make	Toyota	Model	Vios
YOM	2025	Odo Meter Reading	18,165
Registration No.	BAG7316	Chassis No.	PA1B18F38R4273560
CC	1.3	Transmission	CVT
Fuel Type	Gas	Type of Body	Sedan
Colour	Red

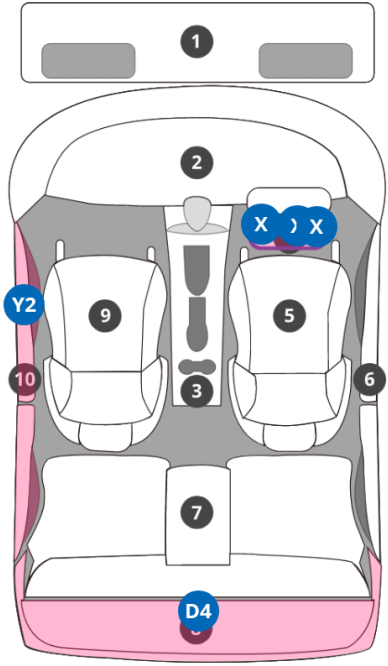
Interior Evaluation : C	Exterior Evaluation : C

<p>a : Cut, Fray d : Loose, Deformed k : Animal Hair s : Smell t : Cigarette Burns x : Defective y : Stain</p>

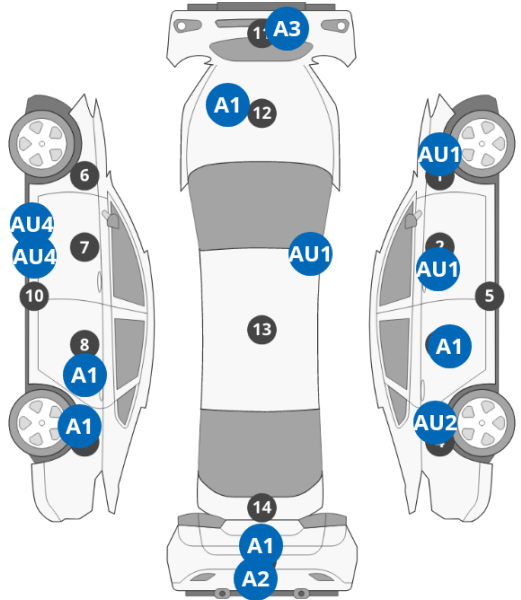
<p>A : Scratch AU : Scratch & Dent B : Modified C : Corrosion G : Stone chip P : Faded S : Rust SC : Rust & Corrosion U : Dent X : Defective Y : Crack, Gap</p>
<p>Remarks (R) Front Floor Mat - Missing - Yes / (L) Front Floor Mat - Missing - Yes / Mat Other - Missing - Yes / Trunk Room - Loose, Deformed - Large / (L) Front Trim - Grime - Small</p>	<p>Remarks (R) Front Fender, Molding - Scratch & Dent - Minimal / (R) Front Door, Molding - Scratch & Dent - Minimal / (R) Rear Door, Molding - Scratch - Minimal / (R) Rear Fender, Molding - Scratch & Dent - Small / Rear Bumper, Lamps, Panels - Scratch - Small / Trunk Hood, Rear Gate - Scratch - Minimal / (L) Rear Fender, Molding - Scratch - Minimal / (L) Rear Door, Molding - Scratch - Minimal / (L) Front Door, Molding - Scratch & Dent - Large / (L) Step, In-panel, Side Spoiler - Scratch & Dent - Large / Bonnet, Headlight - Scratch - Minimal / Roof - Scratch & Dent - Minimal / Front Bumper, Grille, Lamps - Scratch - Medium</p>
