General Information

Make	Toyota	Model	Wigo
YOM	2022	Odo Meter Reading	48,456
Registration No.	NER7358	Chassis No.	MHKA4DF5FMJ064232
CC	1.0	Transmission	A/T
Fuel Type	Gas	Type of Body	Hatchback
Colour	Gray

Body / Panel Condition

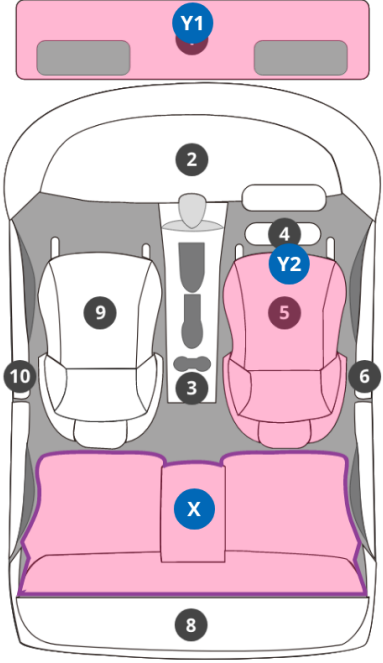
<p>a : Cut, Fray d : Loose, Deformed k : Animal Hair s : Smell t : Cigarette Burns x : Defective y : Stain</p>

<p>A : Scratch AU : Scratch & Dent B : Modified C : Corrosion G : Stone chip P : Faded S : Rust SC : Rust & Corrosion U : Dent X : Defective Y : Crack, Gap</p>
<p>Remarks Ceiling - Grime - Minimal / (R) Front Seat - Grime - Small / Rear Seat Head Rest - Missing - Yes</p>	<p>Remarks (R) Front Fender, Molding - Scratch - Minimal / (R) Mirror - Scratch - Minimal / (R) Front Door, Molding - Scratch - Minimal / (R) Rear Door, Molding - Scratch - Small / (R) Rear Fender, Molding - Scratch - Minimal / Trunk Hood, Rear Gate - Scratch & Dent - Minimal / Rear Bumper, Lamps, Panels - Scratch - Medium / (L) Rear Fender, Molding - Scratch - Minimal / (L) Rear Door, Molding - Scratch - Minimal / (L) Front Door, Molding - Scratch - Minimal / (L) Mirror - Scratch - Minimal / (L) Front Fender, Molding - Scratch - Minimal / Front Bumper, Grille, Lamps - Scratch - Small</p>

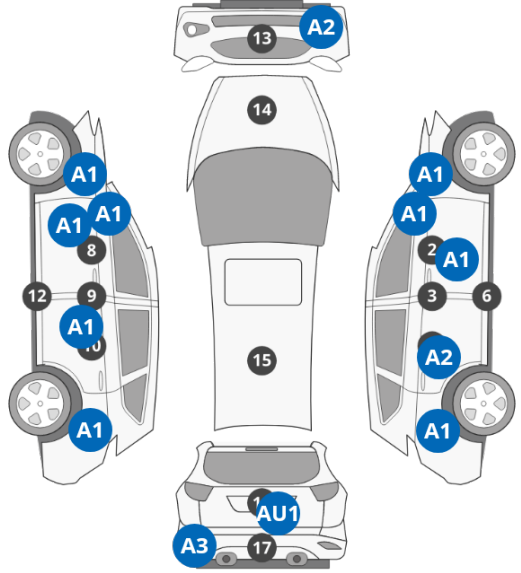
<p>Inspector Notes</p>
<p>With Lto plate, with spare tire, 1key, no warranty booklet, no jack and tools, scratches on headlights and taillights</p>
