General Information

Make	Toyota	Model	Vios
YOM	2024	Odo Meter Reading	21,993
Registration No.	CCC1665	Chassis No.	PA1B18F32P4229714
CC	1.3	Transmission	CVT
Fuel Type	Gas	Type of Body	Sedan
Colour	Red Mica Metallic

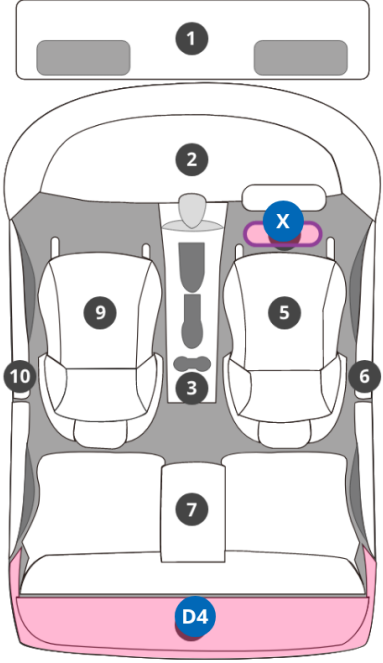
Interior Evaluation : C	Exterior Evaluation : C

<p>a : Cut, Fray d : Loose, Deformed k : Animal Hair s : Smell t : Cigarette Burns x : Defective y : Stain</p>

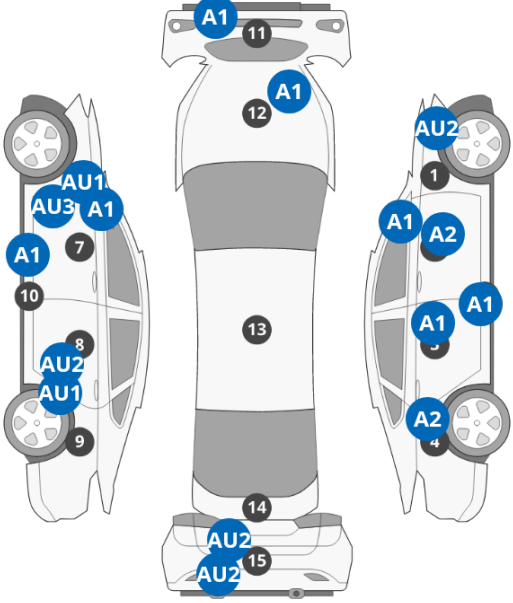
<p>A : Scratch AU : Scratch & Dent B : Modified C : Corrosion G : Stone chip P : Faded S : Rust SC : Rust & Corrosion U : Dent X : Defective Y : Crack, Gap</p>
Remarks (L) Front Floor Mat - Missing - Yes / Trunk Room - Loose, Deformed - Large	Remarks (R) Front Fender, Molding - Scratch & Dent - Small / (R) Mirror - Scratch - Minimal / (R) Front Door, Molding - Scratch - Small / (R) Step, In-panel, Side Spoiler - Scratch - Minimal / (R) Rear Door, Molding - Scratch - Minimal / (R) Rear Fender, Molding - Scratch - Small / Rear Bumper, Lamps, Panels - Scratch & Dent - Small / Trunk Hood, Rear Gate - Scratch & Dent - Small / (L) Rear Fender, Molding - Scratch & Dent - Minimal / (L) Rear Door, Molding - Scratch & Dent - Small / (L) Front Door, Molding - Scratch & Dent - Medium / (L) Mirror - Scratch - Minimal / (L) Step, In-panel, Side Spoiler - Scratch - Minimal / (L) Front Fender, Molding - Scratch & Dent - Minimal / Bonnet, Headlight - Scratch - Minimal / Front Bumper, Grille, Lamps - Scratch - Minimal
