General Information

Make	Mitsubishi	Model	Mirage
YOM	2024	Odo Meter Reading	11,391
Registration No.	NFM3050	Chassis No.	PAEA13TJRRRA029055
CC	1.2	Transmission	CVT
Fuel Type	Gas	Type of Body	Sedan
Colour	Red

Body / Panel Condition

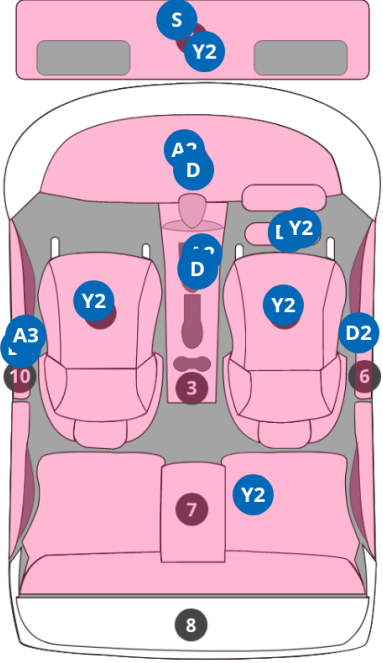
Interior Evaluation : C	Exterior Evaluation : D

<p>a : Cut, Fray d : Loose, Deformed k : Animal Hair s : Smell t : Cigarette Burns x : Defective y : Stain</p>

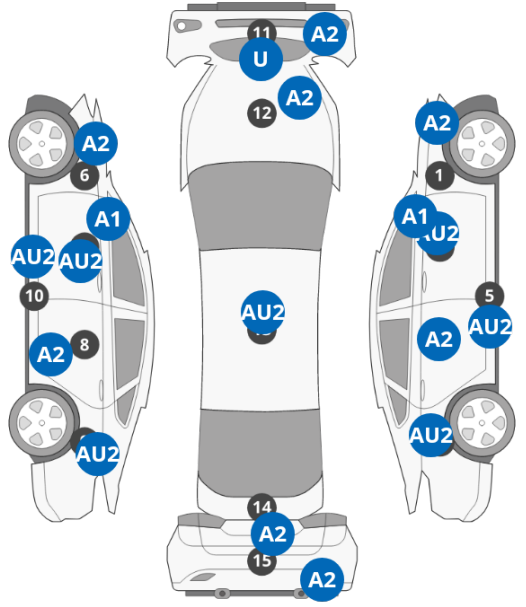
<p>A : Scratch AU : Scratch & Dent B : Modified C : Corrosion G : Stone chip P : Faded S : Rust SC : Rust & Corrosion U : Dent X : Defective Y : Crack, Gap</p>
<p>Remarks (L) Front Floor Mat - Worked - Small / Mat Other - Grime - Small / (L) Front Seat - Grime - Small / (R) Front Seat - Grime - Small / (L) Front Trim - Worked - Small / (R) Front Trim - Worked - Small / Dashboard - Worn, Scratch, Cut, Crack - Small / Dashboard - Traces of Adhesive Tape - Yes / Console, Switches, Vents - Worn, Scratch, Cut, Crack - Small / Console, Switches, Vents - Traces of Adhesive Tape - Yes / Display, Audio System - Stuck - Yes / Ceiling - Grime - Small / Overall Interior - Smell - Yes / Rear Seat - Grime - Small / (L) Front Trim - Cut, Crack - Medium</p>	<p>Remarks Member (Bolted) - Dent - Yes / Front Bumper, Grille, Lamps - Scratch - Small / (R) Front Fender, Molding - Scratch - Small / (R) Front Door, Molding - Scratch & Dent - Small / (R) Rear Door, Molding - Scratch - Small / (R) Rear Fender, Molding - Scratch & Dent - Small / (R) Step, In-panel, Side Spoiler - Scratch & Dent - Small / Trunk Hood, Rear Gate - Scratch - Small / Rear Bumper, Lamps, Panels - Scratch - Small / Roof - Scratch & Dent - Small / Bonnet, Headlight - Scratch - Small / (L) Rear Fender, Molding - Scratch & Dent - Small / (L) Rear Door, Molding - Scratch - Small / (L) Front Door, Molding - Scratch & Dent - Small / (L) Step, In-panel, Side Spoiler - Scratch & Dent - Small / (L) Front Fender, Molding - Scratch - Small / (L) Mirror - Scratch - Minimal / (R) Mirror - Scratch - Minimal</p>
