General Information

Make	Toyota	Model	Vios
YOM	2025	Odo Meter Reading	7,617
Registration No.	DBT1760	Chassis No.	PA1B18F3XS4283769
CC	1.3	Transmission	CVT
Fuel Type	Gas	Type of Body	Sedan
Colour	Black

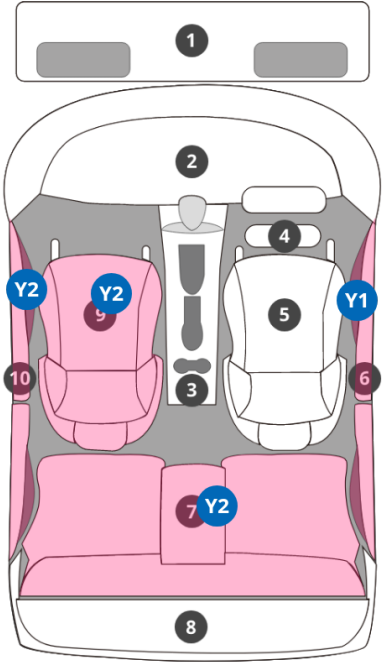
Interior Evaluation : A	Exterior Evaluation : E

<p>a : Cut, Fray d : Loose, Deformed k : Animal Hair s : Smell t : Cigarette Burns x : Defective y : Stain</p>

<p>A : Scratch AU : Scratch & Dent B : Modified C : Corrosion G : Stone chip P : Faded S : Rust SC : Rust & Corrosion U : Dent X : Defective Y : Crack, Gap</p>
<p>Remarks Rear Seat - Grime - Small / (R) Front Trim - Grime - Minimal / (L) Front Trim - Grime - Small / (L) Front Seat - Grime - Small</p>	<p>Remarks (R) Front Fender - Repair Traces - Yes / (L) Rear Door - Repair Traces - Yes / Rear Bumper, Lamps, Panels - Scratch - Medium / (L) Rear Fender, Molding - Scratch & Dent - Large / (L) Rear Door, Molding - Scratch - Medium / (L) Front Door, Molding - Scratch & Dent - Medium / (L) Front Fender, Molding - Scratch & Dent - Large / Front Bumper, Grille, Lamps - Scratch & Dent - Large / (L) Rear Door, Molding - Repair mark - Yes / (R) Front Fender, Molding - Repair mark - Yes / Bonnet, Headlight - Scratch - Minimal / (R) Front Fender, Molding - Scratch - Medium / (R) Mirror - Scratch - Minimal / (R) Front Door, Molding - Scratch - Medium / (R) Rear Door, Molding - Scratch - Small / Trunk Hood, Rear Gate - Scratch - Minimal / Roof - Scratch - Minimal / (L) Mirror - Crack - Damaged</p>

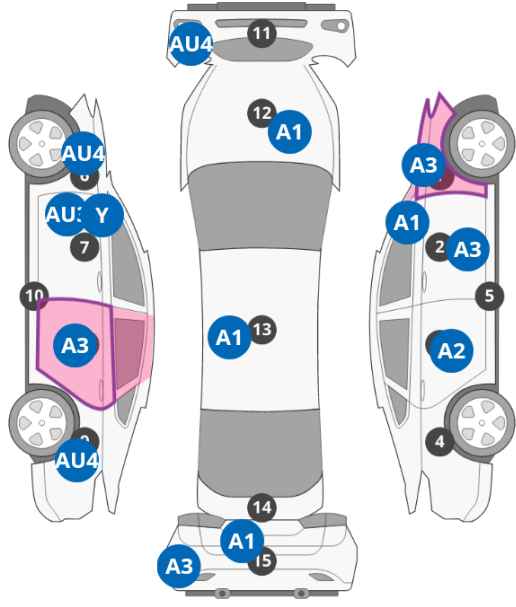
<p>Inspector Notes</p>
<p>with LTO plate/with spare tire/with spare key/with jack and incomplete tools/with reverse camera/with warranty booklet/fuel tank cover damage/left side mirror missing /Left side cheek light missing/left side front door issue</p>
