General Information

Make	Toyota	Model	Wigo
YOM	2025	Odo Meter Reading	2,562
Registration No.	NJQ1300	Chassis No.	MHKAA1BC4SJ036890
CC	1.0	Transmission	CVT
Fuel Type	Gas	Type of Body	Hatchback
Colour	Gray

Body / Panel Condition

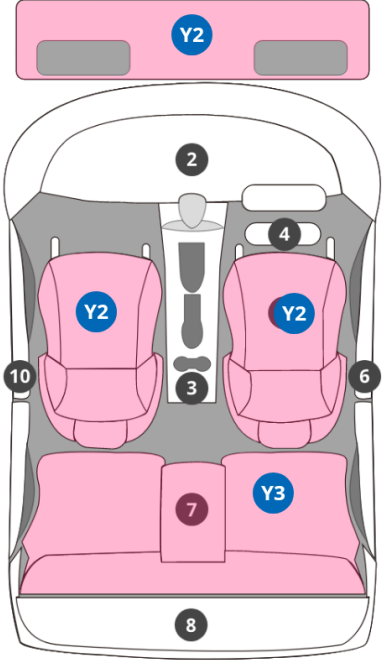
Interior Evaluation : B	Exterior Evaluation : E

<p>a : Cut, Fray d : Loose, Deformed k : Animal Hair s : Smell t : Cigarette Burns x : Defective y : Stain</p>

<p>A : Scratch AU : Scratch & Dent B : Modified C : Corrosion G : Stone chip P : Faded S : Rust SC : Rust & Corrosion U : Dent X : Defective Y : Crack, Gap</p>
<p>Remarks Rear Seat - Grime - Medium / (R) Front Seat - Grime - Small / (L) Front Seat - Grime - Small / Ceiling - Grime - Small</p>	<p>Remarks Trunk Hood, Rear Gate - Dent - Medium / Rear Bumper, Lamps, Panels - Scratch - Small / (L) Rear Fender, Molding - Scratch - Small / (L) Rear Door, Molding - Scratch - Small / (L) Front Door, Molding - Scratch - Medium / (L) Front Fender, Molding - Scratch & Dent - Large / Bonnet, Headlight - Scratch - Small / (R) Front Fender, Molding - Scratch & Dent - Large / (R) Front Door, Molding - Scratch & Dent - Large / Front Bumper, Grille, Lamps - Scratch & Dent - Large / (R) Rear Door, Molding - Scratch - Minimal / (R) Rear Fender, Molding - Scratch - Minimal / Roof - Scratch - Minimal</p>
