General Information

Make	Toyota	Model	Vios
YOM	2024	Odo Meter Reading	36,008
Registration No.	DBF5328	Chassis No.	PA1B18F31R4249813
CC	1.3	Transmission	CVT
Fuel Type	Gas	Type of Body	Sedan
Colour	Black

Body / Panel Condition

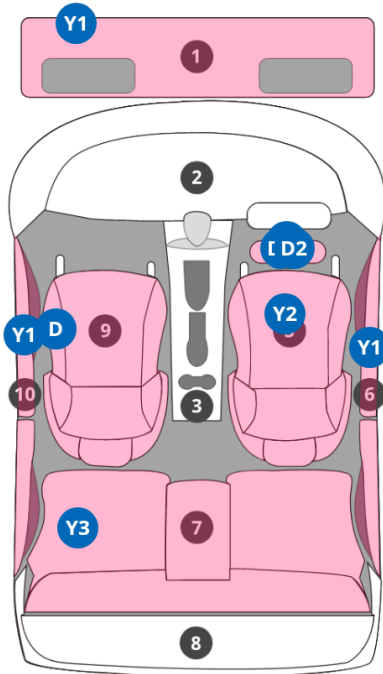
Interior Evaluation : C	Exterior Evaluation : E

<p>a : Cut, Fray d : Loose, Deformed k : Animal Hair s : Smell t : Cigarette Burns x : Defective y : Stain</p>

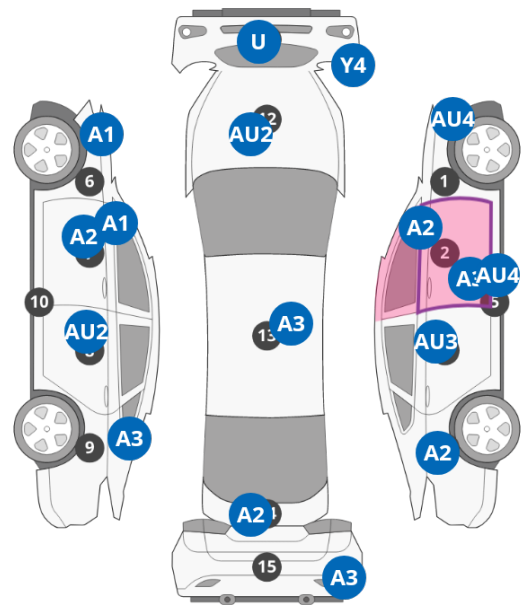
<p>A : Scratch AU : Scratch & Dent B : Modified C : Corrosion G : Stone chip P : Faded S : Rust SC : Rust & Corrosion U : Dent X : Defective Y : Crack, Gap</p>
<p>Remarks Rear Seat - Grime - Medium / (L) Front Floor Mat - Cut, Crack - Medium / (L) Front Floor Mat - Worked - Large / (R) Front Floor Mat - Worked - Large / (L) Front Seat - Worn - Yes / (R) Front Trim - Grime - Minimal / (L) Front Trim - Grime - Minimal / Ceiling - Grime - Minimal / (R) Front Seat - Grime - Small / Mat Other - Worked - Small</p>	<p>Remarks Bonnet - Repair Traces - Yes / (L) Rear Door - Repair Traces - Yes / (R) Front Fender, Molding - Scratch & Dent - Large / (R) Mirror - Scratch - Small / (R) Front Door, Molding - Repair mark - Yes / (R) Front Door, Molding - Scratch - Medium / (R) Rear Door, Molding - Scratch & Dent - Medium / (R) Step, In-panel, Side Spoiler - Scratch & Dent - Large / (R) Rear Fender, Molding - Scratch - Small / Trunk Hood, Rear Gate - Scratch - Small / Rear Bumper, Lamps, Panels - Scratch - Medium / (L) Rear Fender, Molding - Scratch - Medium / (L) Front Door, Molding - Scratch - Small / (L) Rear Door, Molding - Scratch & Dent - Small / (L) Mirror - Scratch - Minimal / Member (Bolted) - Dent - Yes / (L) Front Fender, Molding - Scratch - Minimal / Front Bumper, Grille, Lamps - Crack, Gap - Large / Bonnet, Headlight - Scratch & Dent - Small / Roof - Scratch - Medium</p>
