General Information

Make	Toyota	Model	Vios
YOM	2024	Odo Meter Reading	25,627
Registration No.	DBN9671	Chassis No.	PA1B18F31P4236461
CC	1.3	Transmission	CVT
Fuel Type	Gas	Type of Body	Sedan
Colour	Red

Body / Panel Condition

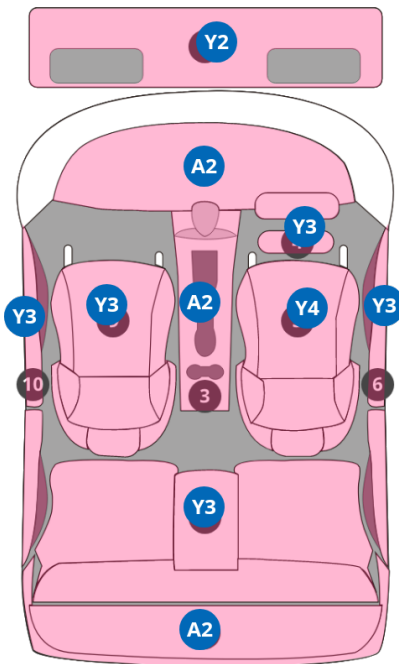
Interior Evaluation : D	Exterior Evaluation : E

<p>a : Cut, Fray d : Loose, Deformed k : Animal Hair s : Smell t : Cigarette Burns x : Defective y : Stain</p>

<p>A : Scratch AU : Scratch & Dent B : Modified C : Corrosion G : Stone chip P : Faded S : Rust SC : Rust & Corrosion U : Dent X : Defective Y : Crack, Gap</p>
<p>Remarks (R) Front Seat - Grime - Large / (R) Front Trim - Grime - Medium / Rear Seat - Grime - Medium / Trunk Room - Worn, Scratch, Cut, Crack - Small / (L) Front Trim - Grime - Medium / (L) Front Seat - Grime - Medium / (L) Front Floor Mat - Grime - Medium / Ceiling - Grime - Small / Dashboard - Worn, Scratch, Cut, Crack - Small / Console, Switches, Vents - Worn, Scratch, Cut, Crack - Small</p>	<p>Remarks (L) Rear Fender, Molding - Scratch & Dent - Medium / Trunk Hood, Rear Gate - Scratch - Medium / Rear Bumper, Lamps, Panels - Scratch - Medium / Bonnet, Headlight - Scratch - Medium / Front Bumper, Grille, Lamps - Scratch - Medium / (R) Front Fender, Molding - Scratch - Medium / (R) Front Door, Molding - Scratch & Dent - Small / (R) Rear Door, Molding - Scratch - Minimal / (R) Rear Fender, Molding - Scratch - Small / (L) Rear Door, Molding - Scratch & Dent - Minimal / (L) Step, In-panel, Side Spoiler - Scratch & Dent - Large / (L) Front Door, Molding - Scratch - Small / Roof - Dent - Small / (L) Front Fender, Molding - Scratch - Small</p>
