## General Information

<b>Make</b>	Toyota	<b>Model</b>	Vios
<b>YOM</b>	2025	<b>Odo Meter Reading</b>	13,651
<b>Registration No.</b>	NJC1409	<b>Chassis No.</b>	PA1B18F32S4285550
<b>CC</b>	1.3	<b>Transmission</b>	CVT
<b>Fuel Type</b>	Gas	<b>Type of Body</b>	Sedan
<b>Colour</b>	Blue

## Body / Panel Condition

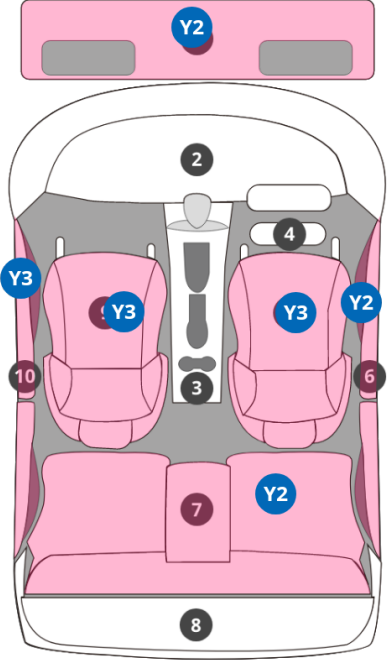
<p><b>a</b> : Cut, Fray <b>d</b> : Loose, Deformed <b>k</b> : Animal Hair <b>s</b> : Smell <b>t</b> : Cigarette Burns <b>x</b> : Defective <b>y</b> : Stain</p>

<p><b>A</b> : Scratch <b>AU</b> : Scratch &amp; Dent <b>B</b> : Modified <b>C</b> : Corrosion <b>G</b> : Stone chip <b>P</b> : Faded <b>S</b> : Rust <b>SC</b> : Rust &amp; Corrosion <b>U</b> : Dent <b>X</b> : Defective <b>Y</b> : Crack, Gap</p>
<p><b>Remarks</b> Rear Seat - Grime - Small / (R) Front Seat - Grime - Medium / (R) Front Trim - Grime - Small / (L) Front Trim - Grime - Medium / (L) Front Seat - Grime - Medium / Ceiling - Grime - Small</p>	<p><b>Remarks</b> (L) Front Fender, Molding - Scratch - Small / Front Bumper, Grille, Lamps - Scratch - Medium / Bonnet, Headlight - Scratch - Minimal / (L) Rear Door, Molding - Scratch - Medium / Trunk Hood, Rear Gate - Scratch - Small / Rear Bumper, Lamps, Panels - Scratch - Medium / (R) Rear Fender, Molding - Scratch &amp; Dent - Medium / (R) Rear Door, Molding - Scratch &amp; Dent - Medium / (R) Front Door, Molding - Scratch &amp; Dent - Medium / (L) Rear Fender, Molding - Scratch - Minimal / (L) Front Door, Molding - Scratch - Minimal</p>
