General Information

Make	Toyota	Model	Vios
YOM	2021	Odo Meter Reading	114,797
Registration No.	DAT9890	Chassis No.	PA1B18F33L4128921
CC	1.3	Transmission	CVT
Fuel Type	Gas	Type of Body	Sedan
Colour	Red

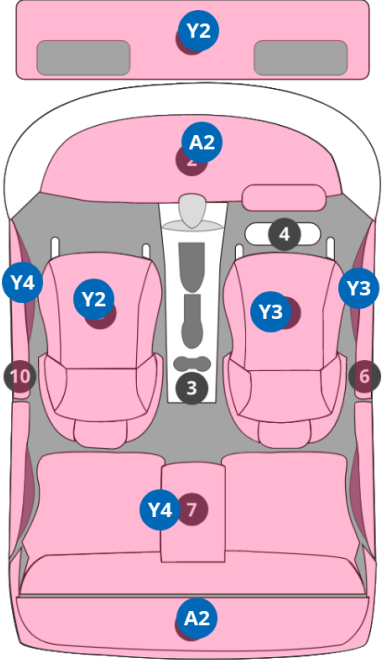
<p>a : Cut, Fray d : Loose, Deformed k : Animal Hair s : Smell t : Cigarette Burns x : Defective y : Stain</p>

<p>A : Scratch AU : Scratch & Dent B : Modified C : Corrosion G : Stone chip P : Faded S : Rust SC : Rust & Corrosion U : Dent X : Defective Y : Crack, Gap</p>
<p>Remarks Rear Seat - Grime - Large / (R) Front Trim - Grime - Medium / (R) Front Seat - Grime - Medium / (L) Front Trim - Grime - Large / (L) Front Seat - Grime - Small / Ceiling - Grime - Small / Dashboard - Worn, Scratch, Cut, Crack - Small / Trunk Room - Worn, Scratch, Cut, Crack - Small</p>	<p>Remarks Bonnet - Repair Traces - Yes / (L) Front Fender - Repair Traces - Yes / (L) Rear Door - Repair Traces - Yes / Roof - Repair Traces - Yes / Bonnet, Headlight - Modified - Large / (L) Rear Fender, Molding - Scratch & Dent - Small / Trunk Hood, Rear Gate - Modified - Large / Rear Bumper, Lamps, Panels - Modified - Large / Trunk Hood, Rear Gate - Scratch - Small / Rear Bumper, Lamps, Panels - Scratch - Small / (R) Rear Fender, Molding - Scratch - Small / (R) Step, In-panel, Side Spoiler - Modified - Large / (R) Rear Door, Molding - Scratch - Small / (R) Front Door, Molding - Scratch - Small / (R) Front Fender, Molding - Scratch & Dent - Medium / Bonnet, Headlight - Scratch - Medium / Front Bumper, Grille, Lamps - Modified - Large / Front Bumper, Grille, Lamps - Crack, Gap - Medium / (L) Front Fender, Molding - Scratch - Minimal / (L) Front Door, Molding - Scratch - Small / (L) Rear Door, Molding - Scratch - Small / (L) Step, In-panel, Side Spoiler - Modified - Large / Roof - Dent - Small</p>

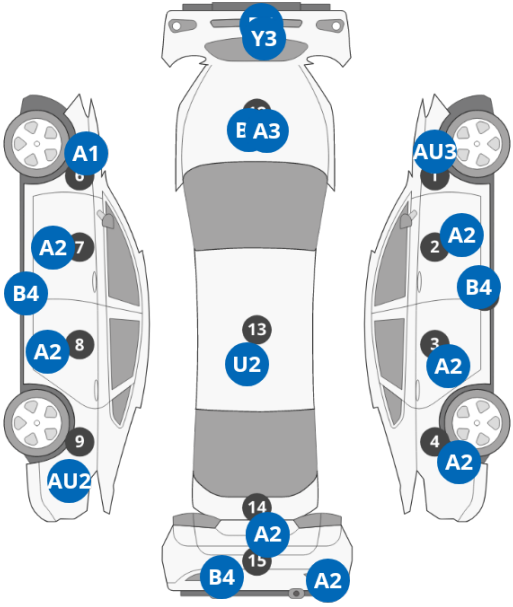
<p>Inspector Notes</p>
<p>with LTO plate/No spare key/No spare tire/with jack No tools/reverse camera not working/No warranty booklet/front and back bumper modified/Roof repainted/open pipe modified/rear seat issue/interior dirty/front and rear door with stickers/trunk room dirty</p>
