General Information

Make	Toyota	Model	Innova
YOM	2025	Odo Meter Reading	18,107
Registration No.	NEY6967	Chassis No.	PA2JA8EM0R0145225
CC	2.8	Transmission	A/T
Fuel Type	Diesel	Type of Body	Wagon
Colour	Blackish Red Mica

Body / Panel Condition

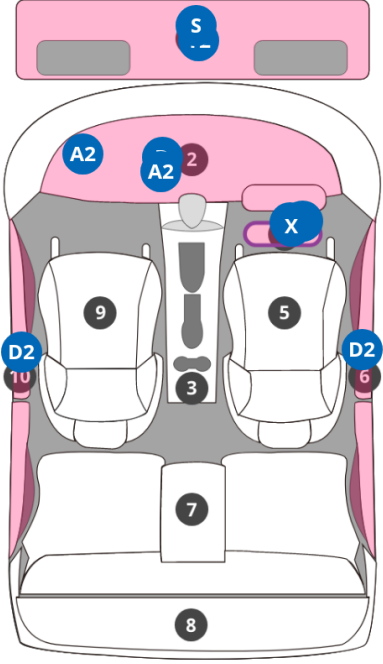
Interior Evaluation : B	Exterior Evaluation : E

<p>a : Cut, Fray d : Loose, Deformed k : Animal Hair s : Smell t : Cigarette Burns x : Defective y : Stain</p>

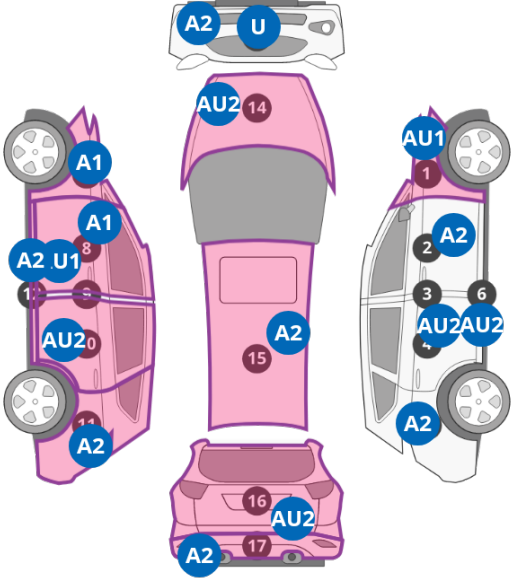
<p>A : Scratch AU : Scratch & Dent B : Modified C : Corrosion G : Stone chip P : Faded S : Rust SC : Rust & Corrosion U : Dent X : Defective Y : Crack, Gap</p>
<p>Remarks (L) Front Floor Mat - Missing - Yes / (R) Front Floor Mat - Missing - Yes / Mat Other - Missing - Yes / Dashboard - Traces of Adhesive Tape - Yes / Dashboard - Worn, Scratch, Cut, Crack - Small / Ceiling - Grime - Small / Overall Interior - Smell - Yes / Steering Wheel - Worn, Peel, Crack - Small / (L) Front Trim - Worked - Small / (R) Front Trim - Worked - Small</p>	<p>Remarks (R) Front Door - Repair Traces - Yes / (R) Step - Repair Traces - Yes / (R) Front Fender - Repair Traces - Yes / Bonnet - Repair Traces - Yes / (L) Front Fender - Repair Traces - Yes / (L) Front Door - Repair Traces - Yes / (L) Step - Repair Traces - Yes / (L) Step - Replaced - Yes / (L) Rear Door - Repair Traces - Yes / (L) Rear Fender - Repair Traces - Yes / Trunk Hood, Rear Gate - Repair Traces - Yes / Rear End Panel - Replaced - Yes / (L) Rear Fender, Molding - Repair mark - Yes / (L) Rear Door, Molding - Repair mark - Yes / (L) Front Door, Molding - Repair mark - Yes / (L) Front Fender, Molding - Repair mark - Yes / Bonnet, Headlight - Repair mark - Yes / Trunk Hood, Rear Gate - Repair mark - Yes / (R) Front Fender, Molding - Repair mark - Yes / Roof - Repair mark - Yes / Member (Bolted) - Dent - Yes / (L) Front Fender, Molding - Scratch - Minimal / (L) Front Door, Molding - Scratch & Dent - Minimal / (L) Rear Door, Molding - Scratch & Dent - Small / (L) Rear Fender, Molding - Scratch - Small / (L) Step, In-panel, Side Spoiler - Scratch - Small / (L) Mirror - Scratch - Minimal / Bonnet, Headlight - Scratch & Dent - Small / (R) Front Fender, Molding - Scratch & Dent - Minimal / (R) Front Door, Molding - Scratch - Small / (R) Rear Door, Molding - Scratch & Dent - Small / (R) Step, In-panel, Side Spoiler - Scratch & Dent - Small / (R) Rear Fender, Molding - Scratch - Small / Roof - Scratch - Small / Trunk Hood, Rear Gate - Scratch & Dent - Small / Rear Bumper, Lamps, Panels - Scratch - Small / Front Bumper, Grille, Lamps - Scratch - Small</p>
