General Information

Make	Kia	Model	Seltos
YOM	2024	Odo Meter Reading	2,156
Registration No.	NKT3258	Chassis No.	LJD5AA19BR0117881
CC	1.4	Transmission	A/T
Fuel Type	Gas	Type of Body	SUV
Colour	White

Body / Panel Condition

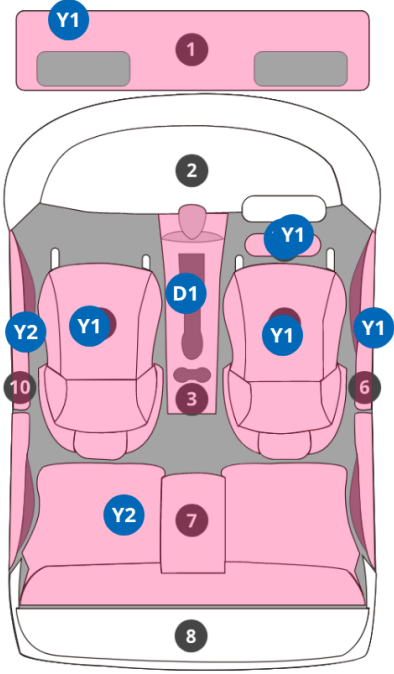
Interior Evaluation : B	Exterior Evaluation : C

<p>a : Cut, Fray d : Loose, Deformed k : Animal Hair s : Smell t : Cigarette Burns x : Defective y : Stain</p>

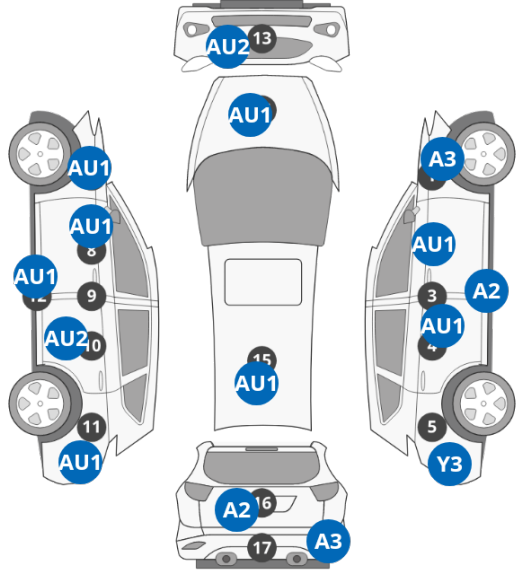
<p>A : Scratch AU : Scratch & Dent B : Modified C : Corrosion G : Stone chip P : Faded S : Rust SC : Rust & Corrosion U : Dent X : Defective Y : Crack, Gap</p>
<p>Remarks (L) Front Seat - Grime - Minimal / (R) Front Seat - Grime - Minimal / Ceiling - Grime - Minimal / Rear Seat - Grime - Small / (L) Front Trim - Grime - Small / (R) Front Trim - Grime - Minimal / Console, Switches, Vents - Worked - Minimal / (R) Front Floor Mat - Grime - Minimal / (L) Front Floor Mat - Grime - Minimal</p>	<p>Remarks Trunk Hood, Rear Gate - Repair Traces - Yes / Roof - Repair Traces - Yes / Rear Bumper, Lamps, Panels - Scratch - Medium / (R) Rear Fender, Molding - Crack, Gap - Medium / Trunk Hood, Rear Gate - Scratch - Small / (L) Rear Door, Molding - Scratch & Dent - Small / (L) Front Door, Molding - Scratch & Dent - Minimal / (L) Step, In-panel, Side Spoiler - Scratch & Dent - Minimal / (L) Front Fender, Molding - Scratch & Dent - Minimal / (R) Front Fender, Molding - Scratch - Medium / (R) Front Door, Molding - Scratch & Dent - Minimal / (R) Rear Door, Molding - Scratch & Dent - Minimal / (R) Step, In-panel, Side Spoiler - Scratch - Small / Bonnet, Headlight - Scratch & Dent - Minimal / Front Bumper, Grille, Lamps - Scratch & Dent - Small / Roof - Scratch & Dent - Minimal / (L) Rear Fender, Molding - Scratch & Dent - Minimal</p>
