General Information

Make	Toyota	Model	Vios
YOM	2025	Odo Meter Reading	11,601
Registration No.	NJE4732	Chassis No.	PA1B18F30S4283649
CC	1.3	Transmission	CVT
Fuel Type	Gas	Type of Body	Sedan
Colour	Red

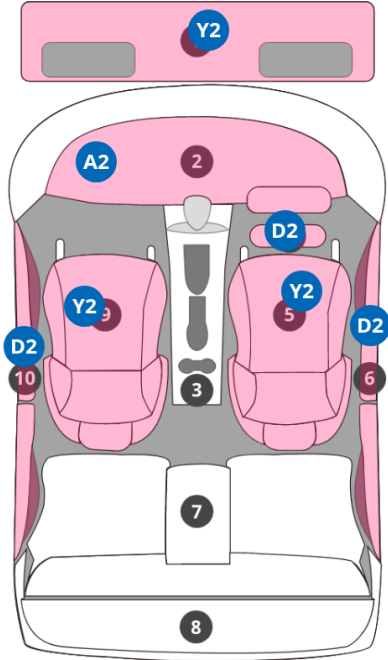
Interior Evaluation : B	Exterior Evaluation : C

<p>a : Cut, Fray d : Loose, Deformed k : Animal Hair s : Smell t : Cigarette Burns x : Defective y : Stain</p>

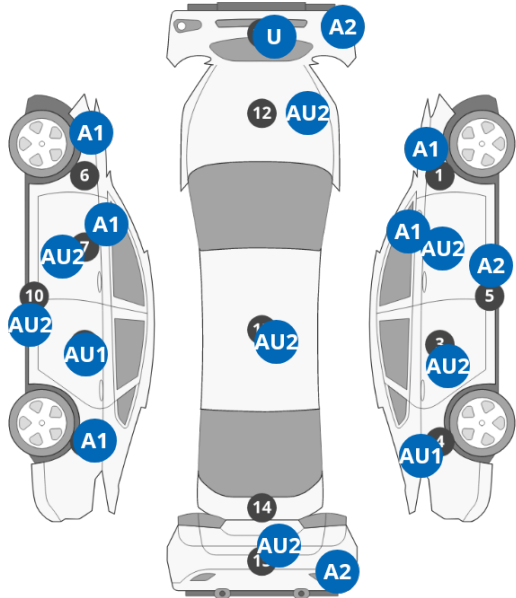
<p>A : Scratch AU : Scratch & Dent B : Modified C : Corrosion G : Stone chip P : Faded S : Rust SC : Rust & Corrosion U : Dent X : Defective Y : Crack, Gap</p>
<p>Remarks (L) Front Trim - Worked - Small / (R) Front Trim - Worked - Small / (L) Front Floor Mat - Worked - Small / Ceiling - Grime - Small / (L) Front Seat - Grime - Small / (R) Front Seat - Grime - Small / Steering Wheel - Worn, Peel, Crack - Small</p>	<p>Remarks Member (Bolted) - Dent - Yes / (L) Front Fender, Molding - Scratch - Minimal / (L) Front Door, Molding - Scratch & Dent - Small / (L) Rear Door, Molding - Scratch & Dent - Minimal / (L) Step, In-panel, Side Spoiler - Scratch & Dent - Small / (L) Rear Fender, Molding - Scratch - Minimal / Front Bumper, Grille, Lamps - Scratch - Small / Bonnet, Headlight - Scratch & Dent - Small / (R) Front Fender, Molding - Scratch - Minimal / (R) Front Door, Molding - Scratch & Dent - Small / (R) Step, In-panel, Side Spoiler - Scratch - Small / (R) Rear Door, Molding - Scratch & Dent - Small / (R) Rear Fender, Molding - Scratch & Dent - Minimal / Rear Bumper, Lamps, Panels - Scratch - Small / Trunk Hood, Rear Gate - Scratch & Dent - Small / Roof - Scratch & Dent - Small / (L) Mirror - Scratch - Minimal / (R) Mirror - Scratch - Minimal</p>
