General Information

Make	Ford	Model	Territory
YOM	2021	Odo Meter Reading	51,500
Registration No.	NGA6738	Chassis No.	LJXCU2BBXLTP24939
CC	1.5	Transmission	A/T
Fuel Type	Gas	Type of Body	SUV
Colour	Red

Body / Panel Condition

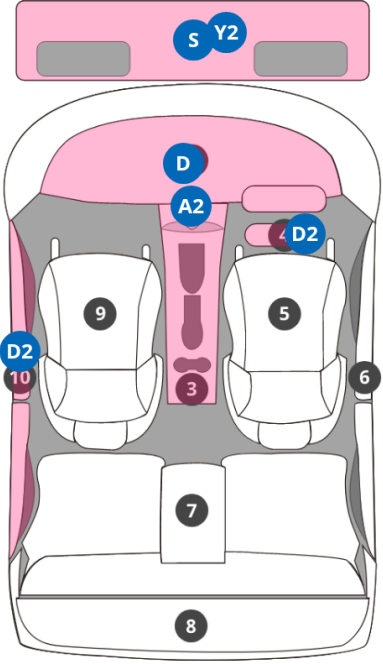
Interior Evaluation : B	Exterior Evaluation : E

<p>a : Cut, Fray d : Loose, Deformed k : Animal Hair s : Smell t : Cigarette Burns x : Defective y : Stain</p>

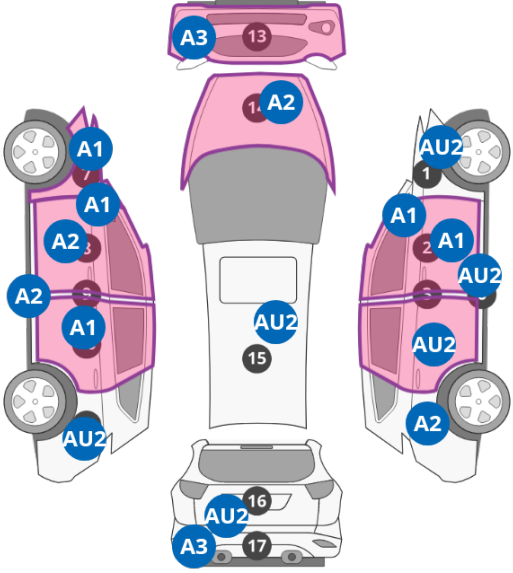
<p>A : Scratch AU : Scratch & Dent B : Modified C : Corrosion G : Stone chip P : Faded S : Rust SC : Rust & Corrosion U : Dent X : Defective Y : Crack, Gap</p>
Remarks (L) Front Trim - Worked - Small / (L) Front Floor Mat - Worked - Small / Ceiling - Grime - Small / Overall Interior - Smell - Yes / Dashboard - Traces of Adhesive Tape - Yes / Console, Switches, Vents - Worn, Scratch, Cut, Crack - Small	Remarks (R) Front Door - Repair Traces - Yes / Bonnet - Repair Traces - Yes / (L) Front Fender - Repair Traces - Yes / (L) Front Door - Repair Traces - Yes / (R) Rear Door - Repair Traces - Yes / (L) Front Fender, Molding - Repair mark - Yes / (L) Front Door, Molding - Repair mark - Yes / (L) Rear Door, Molding - Repair mark - Yes / (R) Front Door, Molding - Repair mark - Yes / (R) Rear Door, Molding - Repair mark - Yes / Bonnet, Headlight - Repair mark - Yes / Front Bumper, Grille, Lamps - Repair mark - Yes / Bonnet, Headlight - Scratch - Small / Front Bumper, Grille, Lamps - Scratch - Medium / (L) Front Fender, Molding - Scratch - Minimal / (L) Front Door, Molding - Scratch - Small / (L) Rear Door, Molding - Scratch - Minimal / (L) Rear Fender, Molding - Scratch & Dent - Small / (L) Step, In-panel, Side Spoiler - Scratch - Small / (L) Mirror - Scratch - Minimal / Rear Bumper, Lamps, Panels - Scratch - Medium / Trunk Hood, Rear Gate - Scratch & Dent - Small / (R) Rear Fender, Molding - Scratch - Small / (R) Rear Door, Molding - Scratch & Dent - Small / (R) Front Door, Molding - Scratch - Minimal / (R) Front Fender, Molding - Scratch & Dent - Small / (R) Step, In-panel, Side Spoiler - Scratch & Dent - Small / Roof - Scratch & Dent - Small / (R) Mirror - Scratch - Minimal
