General Information

Make	Toyota	Model	Vios
YOM	2019	Odo Meter Reading	64,710
Registration No.	DAJ2311	Chassis No.	PA1B18F3XJ4072167
CC	1.3	Transmission	M/T
Fuel Type	Gas	Type of Body	Sedan
Colour	Blackish Red Mica

Body / Panel Condition

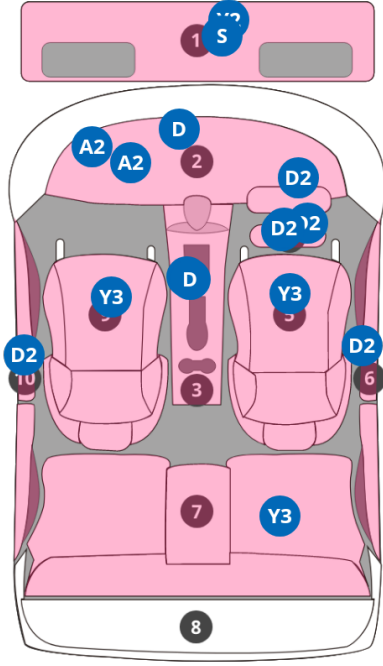
Interior Evaluation : D	Exterior Evaluation : E

<p>a : Cut, Fray d : Loose, Deformed k : Animal Hair s : Smell t : Cigarette Burns x : Defective y : Stain</p>

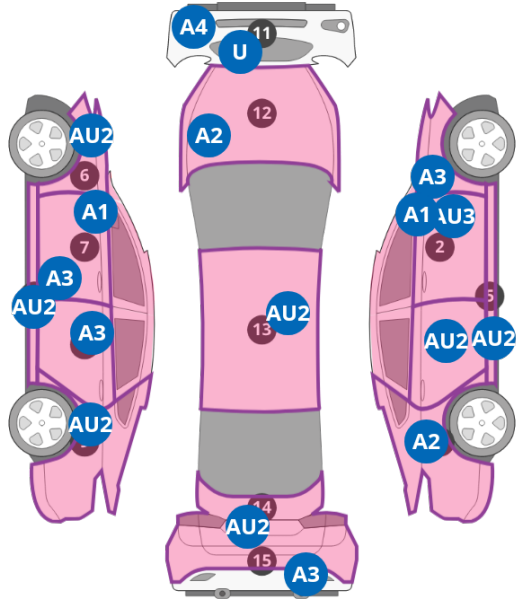
<p>A : Scratch AU : Scratch & Dent B : Modified C : Corrosion G : Stone chip P : Faded S : Rust SC : Rust & Corrosion U : Dent X : Defective Y : Crack, Gap</p>
Remarks (L) Front Floor Mat - Worked - Small / (L) Front Trim - Worked - Small / (R) Front Trim - Worked - Small / Console, Switches, Vents - Worn, Scratch, Cut, Crack - Small / Console, Switches, Vents - Traces of Adhesive Tape - Yes / Dashboard - Traces of Adhesive Tape - Yes / Dashboard - Worn, Scratch, Cut, Crack - Small / Steering Wheel - Worn, Peel, Crack - Small / Glove Box - Loose, Deformed - Small / Rear Seat - Grime - Medium / (R) Front Floor Mat - Worked - Small / Mat Other - Worked - Small / (R) Front Seat - Grime - Medium / (L) Front Seat - Grime - Medium / Ceiling - Grime - Small / Overall Interior - Smell - Yes	Remarks (R) Front Door - Repair Traces - Yes / (R) Step - Repair Traces - Yes / (R) Front Fender - Repair Traces - Yes / Bonnet - Repair Traces - Yes / (L) Front Fender - Repair Traces - Yes / (L) Front Door - Repair Traces - Yes / (L) Step - Repair Traces - Yes / (L) Rear Door - Repair Traces - Yes / (L) Rear Fender - Repair Traces - Yes / Trunk Hood, Rear Gate - Repair Traces - Yes / (R) Rear Door - Repair Traces - Yes / Roof - Repair Traces - Yes / Member (Bolted) - Dent - Yes / (L) Front Fender, Molding - Repair mark - Yes / (L) Front Door, Molding - Repair mark - Yes / (L) Rear Door, Molding - Repair mark - Yes / (L) Rear Fender, Molding - Repair mark - Difference in Color / (L) Step, In-panel, Side Spoiler - Repair mark - Yes / Trunk Hood, Rear Gate - Repair mark - Yes / Roof - Repair mark - Yes / Bonnet, Headlight - Repair mark - Yes / (R) Front Fender, Molding - Repair mark - Yes / (R) Front Door, Molding - Repair mark - Yes / (R) Rear Door, Molding - Repair mark - Yes / (R) Step, In-panel, Side Spoiler - Repair mark - Yes / (R) Rear Fender, Molding - Repair mark - Yes / Front Bumper, Grille, Lamps - Scratch - Large / Bonnet, Headlight - Scratch - Small / (L) Front Fender, Molding - Scratch & Dent - Small / (L) Front Door, Molding - Scratch - Medium / (L) Rear Door, Molding - Scratch - Medium / (L) Rear Fender, Molding - Scratch & Dent - Small / (L) Step, In-panel, Side Spoiler - Scratch & Dent - Small / Trunk Hood, Rear Gate - Scratch & Dent - Small / Rear Bumper, Lamps, Panels - Scratch - Medium / (R) Rear Fender, Molding - Scratch - Small / (R) Rear Door, Molding - Scratch & Dent - Small / (R) Step, In-panel, Side Spoiler - Scratch & Dent - Small / (R) Front Door, Molding - Scratch & Dent - Medium / (R) Front Fender, Molding - Scratch - Medium / (R) Mirror - Scratch - Minimal / (L) Mirror - Scratch - Minimal / Roof - Scratch & Dent - Small
