General Information

Make	Nissan	Model	NV350
YOM	2018	Odo Meter Reading	79,010
Registration No.	NEA6691	Chassis No.	JNTC2E26Z0053817
CC	2.5	Transmission	M/T
Fuel Type	Diesel	Type of Body	Van
Colour	Black

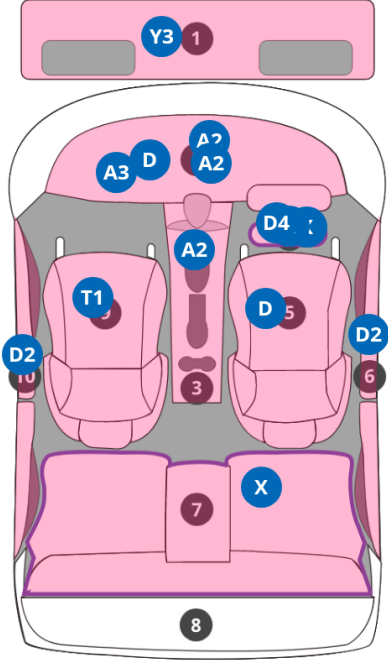
Interior Evaluation : D	Exterior Evaluation : E

<p>a : Cut, Fray d : Loose, Deformed k : Animal Hair s : Smell t : Cigarette Burns x : Defective y : Stain</p>

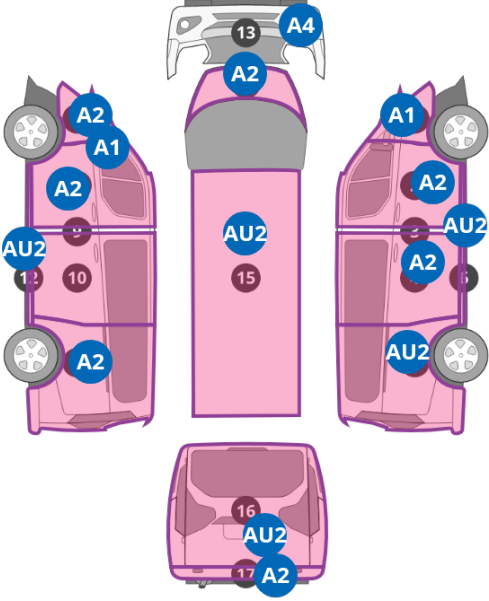
<p>A : Scratch AU : Scratch & Dent B : Modified C : Corrosion G : Stone chip P : Faded S : Rust SC : Rust & Corrosion U : Dent X : Defective Y : Crack, Gap</p>
<p>Remarks Rear Seat - Missing - Yes / Ceiling - Grime - Medium / (L) Front Seat - Cigarette Burns - Burnt Minimal / (R) Front Seat - Worn - Yes / Dashboard - Worn, Scratch, Cut, Crack - Small / Glove Box - Worn, Scratch, Cut, Crack - Small / Dashboard - Traces of Adhesive Tape - Yes / Console, Switchs, Vents - Worn, Scratch, Cut, Crack - Small / (L) Front Trim - Worked - Small / (R) Front Trim - Worked - Small / (L) Front Floor Mat - Missing - Yes / (R) Front Floor Mat - Missing - Yes / Steering Wheel - Worn, Peel, Crack - Medium / Mat Other - Worked - Large</p>	<p>Remarks (R) Front Door - Repair Traces - Yes / (R) Step - Repair Traces - Yes / (L) Front Door - Repair Traces - Yes / (L) Step - Repair Traces - Yes / (R) Rear Door - Repair Traces - Yes / Roof - Repair Traces - Yes / Roof - Repair mark - Yes / (R) Front Door, Molding - Repair mark - Yes / (R) Step, In-panel, Side Spoiler - Repair mark - Yes / (L) Step, In-panel, Side Spoiler - Repair mark - Yes / Front Panel - Repair mark - Yes / (L) Front Fender, Molding - Repair mark - Yes / (R) Front Fender, Molding - Repair mark - Yes / (R) Rear Door, Molding - Repair mark - Yes / (L) Front Door, Molding - Repair mark - Yes / (L) Rear Door, Molding - Repair mark - Yes / (L) Rear Fender, Molding - Repair mark - Yes / (R) Rear Fender, Molding - Repair mark - Yes / Trunk Hood, Rear Gate - Repair mark - Yes / (L) Rear Fender, Molding - Scratch - Small / (L) Front Door, Molding - Scratch - Small / (L) Front Fender, Molding - Scratch - Small / (L) Mirror - Scratch - Minimal / Front Bumper, Grille, Lamps - Scratch - Large / (R) Front Fender, Molding - Scratch - Minimal / (R) Front Door, Molding - Scratch - Small / (R) Rear Door, Molding - Scratch - Small / (R) Step, In-panel, Side Spoiler - Scratch & Dent - Small / (R) Rear Fender, Molding - Scratch & Dent - Small / Trunk Hood, Rear Gate - Scratch & Dent - Small / Rear Bumper, Lamps, Panels - Scratch - Small / Rear Bumper, Lamps, Panels - Repair mark - Yes / (L) Step, In-panel, Side Spoiler - Scratch & Dent - Small / Roof - Scratch & Dent - Small / Front Panel - Scratch - Small</p>
