General Information

Make	Mitsubishi	Model	Mirage
YOM	2014	Odo Meter Reading	79,890
Registration No.	AJA2535	Chassis No.	MMBSTA13AEH020342
CC	1.2	Transmission	A/T
Fuel Type	Gas	Type of Body	Sedan
Colour	Gray

Body / Panel Condition

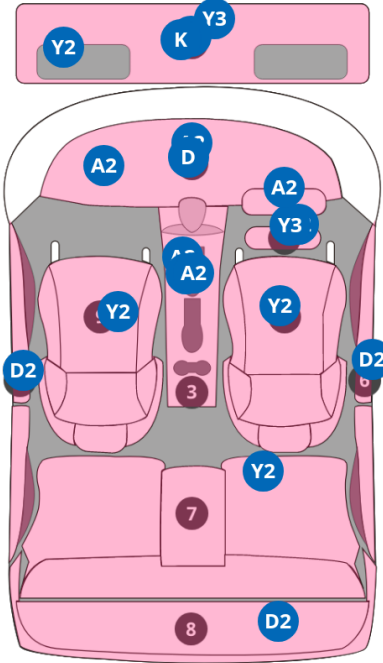
Interior Evaluation : E	Exterior Evaluation : E

<p>a : Cut, Fray d : Loose, Deformed k : Animal Hair s : Smell t : Cigarette Burns x : Defective y : Stain</p>

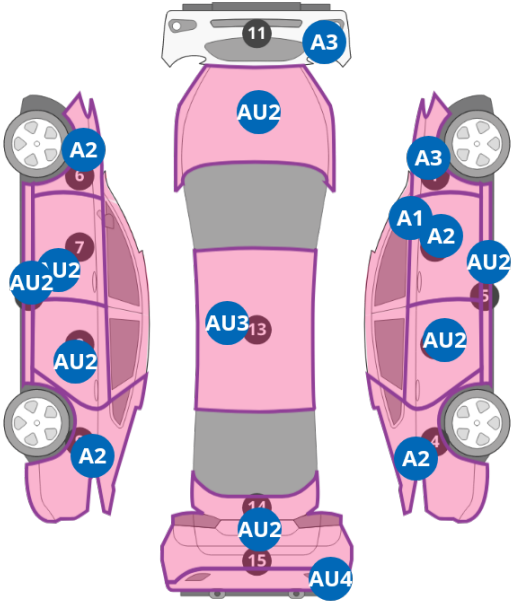
<p>A : Scratch AU : Scratch & Dent B : Modified C : Corrosion G : Stone chip P : Faded S : Rust SC : Rust & Corrosion U : Dent X : Defective Y : Crack, Gap</p>
Remarks (L) Front Floor Mat - Worked - Small / (L) Front Trim - Worked - Small / (L) Front Seat - Grime - Small / (R) Front Seat - Grime - Small / Mat Other - Grime - Medium / Rear Seat - Grime - Small / Dashboard - Worn, Scratch, Cut, Crack - Small / Dashboard - Traces of Adhesive Tape - Yes / Steering Wheel - Worn, Peel, Crack - Small / Glove Box - Worn, Scratch, Cut, Crack - Small / Console, Switches, Vents - Worn, Scratch, Cut, Crack - Small / Console, Switches, Vents - Traces of Adhesive Tape - Yes / Knobs - Worn, Peel, Crack - Small / Ceiling - Grime - Medium / Sunvisor, Sunglass Holder - Grime - Small / Switches - Partially Missing - Yes / Overall Interior - Smell - Yes / Overall Interior - Worn as per age - Yes / Overall Interior - Animal Hair - Yes / Trunk Room - Loose, Deformed - Small / (R) Front Trim - Worked - Small	Remarks (R) Front Door - Repair Traces - Yes / (R) Step - Repair Traces - Yes / (R) Front Fender - Repair Traces - Yes / Bonnet - Repair Traces - Yes / (L) Front Fender - Repair Traces - Yes / (L) Front Door - Repair Traces - Yes / (L) Step - Repair Traces - Yes / (L) Rear Door - Repair Traces - Yes / (L) Rear Fender - Repair Traces - Yes / Trunk Hood, Rear Gate - Repair Traces - Yes / (R) Rear Fender - Repair Traces - Yes / (R) Rear Door - Repair Traces - Yes / Roof - Repair Traces - Yes / Bonnet, Headlight - Repair mark - Yes / (R) Front Fender, Molding - Repair mark - Yes / (L) Front Fender, Molding - Repair mark - Yes / (L) Front Door, Molding - Repair mark - Yes / (L) Rear Door, Molding - Repair mark - Yes / (L) Step, In-panel, Side Spoiler - Repair mark - Yes / (L) Rear Fender, Molding - Repair mark - Yes / Roof - Repair mark - Yes / (R) Front Door, Molding - Repair mark - Yes / (R) Rear Door, Molding - Repair mark - Yes / (R) Step, In-panel, Side Spoiler - Repair mark - Yes / (R) Rear Fender, Molding - Repair mark - Yes / Trunk Hood, Rear Gate - Repair mark - Yes / Bonnet, Headlight - Scratch & Dent - Small / Front Bumper, Grille, Lamps - Scratch - Medium / (R) Front Fender, Molding - Scratch - Medium / (R) Mirror - Scratch - Minimal / (R) Step, In-panel, Side Spoiler - Scratch & Dent - Small / (R) Rear Door, Molding - Scratch & Dent - Small / (R) Front Door, Molding - Scratch - Small / (R) Rear Fender, Molding - Scratch - Small / Rear Bumper, Lamps, Panels - Scratch & Dent - Large / Rear Bumper, Lamps, Panels - Repair mark - Yes / Trunk Hood, Rear Gate - Scratch & Dent - Small / (L) Rear Fender, Molding - Scratch - Small / (L) Rear Door, Molding - Scratch & Dent - Small / (L) Front Door, Molding - Scratch & Dent - Small / (L) Step, In-panel, Side Spoiler - Scratch & Dent - Small / (L) Front Fender, Molding - Scratch - Small / Roof - Scratch & Dent - Medium
