## General Information

<b>Make</b>	Mitsubishi	<b>Model</b>	Mirage
<b>YOM</b>	2022	<b>Odo Meter Reading</b>	46,662
<b>Registration No.</b>	NGQ4052	<b>Chassis No.</b>	PAEA03RJNNA005043
<b>CC</b>	1.2	<b>Transmission</b>	A/T
<b>Fuel Type</b>	Gas	<b>Type of Body</b>	Hatchback
<b>Colour</b>	Gray

## Body / Panel Condition

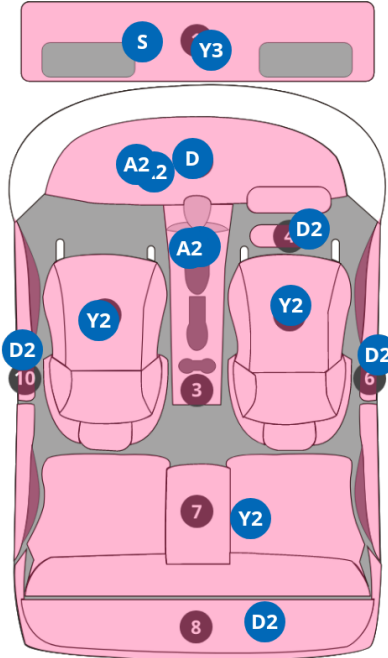
<p><b>Interior Evaluation :</b> <span style="color: red; font-weight: bold; font-size: 1.2em;">C</span></p>	<p><b>Exterior Evaluation :</b> <span style="color: red; font-weight: bold; font-size: 1.2em;">E</span></p>
<div style="text-align: center;">

</div> <p><b>a :</b> Cut, Fray <b>d :</b> Loose, Deformed <b>k :</b> Animal Hair <b>s :</b> Smell <b>t :</b> Cigarette Burns <b>x :</b> Defective <b>y :</b> Stain</p>	<div style="text-align: center;">

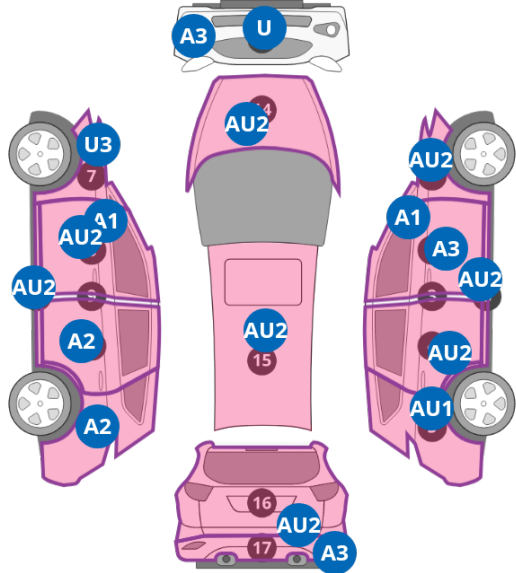
</div> <p><b>A :</b> Scratch <b>AU :</b> Scratch &amp; Dent <b>B :</b> Modified <b>C :</b> Corrosion <b>G :</b> Stone chip <b>P :</b> Faded <b>S :</b> Rust <b>SC :</b> Rust &amp; Corrosion <b>U :</b> Dent <b>X :</b> Defective <b>Y :</b> Crack, Gap</p>
<p><b>Remarks</b></p> <p>(L) Front Floor Mat - Worked - Small / (L) Front Seat - Grime - Small / (R) Front Seat - Grime - Small / Rear Seat - Grime - Small / Dashboard - Traces of Adhesive Tape - Yes / Dashboard - Worn, Scratch, Cut, Crack - Small / Steering Wheel - Worn, Peel, Crack - Small / Console, Switches, Vents - Traces of Adhesive Tape - Yes / Console, Switches, Vents - Worn, Scratch, Cut, Crack - Small / Room Mirror - Stuck - Yes / Ceiling - Grime - Medium / Overall Interior - Smell - Yes / (L) Front Trim - Worked - Small / (R) Front Trim - Worked - Small / Trunk Room - Loose, Deformed - Small</p>	<p><b>Remarks</b></p> <p>(R) Front Door - Repair Traces - Yes / (R) Step - Repair Traces - Yes / (R) Step - Replaced - Yes / (R) Front Fender - Repair Traces - Yes / Bonnet - Repair Traces - Yes / (L) Front Fender - Repair Traces - Yes / (L) Front Door - Repair Traces - Yes / (L) Step - Repair Traces - Yes / (L) Step - Replaced - Yes / (L) Rear Door - Repair Traces - Yes / (L) Rear Fender - Repair Traces - Yes / Trunk Hood, Rear Gate - Repair Traces - Yes / Rear End Panel - Replaced - Yes / (R) Rear Fender - Repair Traces - Yes / (R) Rear Door - Repair Traces - Yes / Roof - Repair Traces - Yes / Roof - Replaced - Yes / (L) Rear Door, Molding - Repair mark - Yes / (L) Front Door, Molding - Repair mark - Yes / (L) Front Fender, Molding - Repair mark - Yes / Bonnet, Headlight - Repair mark - Yes / (R) Front Fender, Molding - Repair mark - Yes / (R) Front Door, Molding - Repair mark - Yes / (R) Rear Door, Molding - Repair mark - Yes / (R) Rear Fender, Molding - Repair mark - Yes / Trunk Hood, Rear Gate - Repair mark - Yes / (L) Rear Fender, Molding - Repair mark - Yes / Member (Bolted) - Dent - Yes / (L) Mirror - Scratch - Minimal / (R) Mirror - Scratch - Minimal / (L) Front Fender, Molding - Dent - Medium / (L) Front Door, Molding - Scratch &amp; Dent - Small / (L) Rear Door, Molding - Scratch - Small / (L) Step, In-panel, Side Spoiler - Scratch &amp; Dent - Small / (L) Rear Fender, Molding - Scratch - Small / Front Bumper, Grille, Lamps - Scratch - Medium / Bonnet, Headlight - Scratch &amp; Dent - Small / (R) Front Fender, Molding - Scratch &amp; Dent - Small / (R) Front Door, Molding - Scratch - Medium / (R) Rear Door, Molding - Scratch &amp; Dent - Small / (R) Rear Fender, Molding - Scratch &amp; Dent - Minimal / (R) Step, In-panel, Side Spoiler - Scratch &amp; Dent - Small / Rear Bumper, Lamps, Panels - Scratch - Medium / Trunk Hood, Rear Gate - Scratch &amp; Dent - Small / Roof - Scratch &amp; Dent - Small</p>
