General Information

Make	Toyota	Model	Vios
YOM	2024	Odo Meter Reading	15,299
Registration No.	BAG3008	Chassis No.	PA1B18F32R4250002
CC	1.3	Transmission	CVT
Fuel Type	Gas	Type of Body	Sedan
Colour	Red

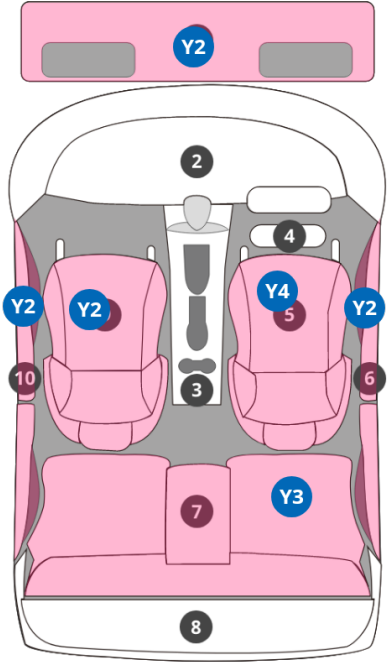
Interior Evaluation : C	Exterior Evaluation : C

<p>a : Cut, Fray d : Loose, Deformed k : Animal Hair s : Smell t : Cigarette Burns x : Defective y : Stain</p>

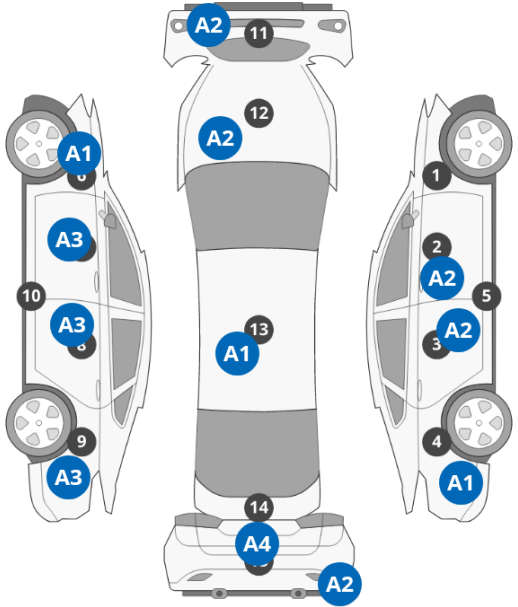
<p>A : Scratch AU : Scratch & Dent B : Modified C : Corrosion G : Stone chip P : Faded S : Rust SC : Rust & Corrosion U : Dent X : Defective Y : Crack, Gap</p>
<p>Remarks Rear Seat - Grime - Medium / (R) Front Trim - Grime - Small / (R) Front Seat - Grime - Large / (L) Front Trim - Grime - Small / (L) Front Seat - Grime - Small / Ceiling - Grime - Small</p>	<p>Remarks Trunk Hood, Rear Gate - Scratch - Large / (L) Front Fender, Molding - Scratch - Minimal / (L) Front Door, Molding - Scratch - Medium / (L) Rear Door, Molding - Scratch - Medium / (L) Rear Fender, Molding - Scratch - Medium / (R) Rear Fender, Molding - Scratch - Minimal / Rear Bumper, Lamps, Panels - Scratch - Small / (R) Rear Door, Molding - Scratch - Small / (R) Front Door, Molding - Scratch - Small / Bonnet, Headlight - Scratch - Small / Front Bumper, Grille, Lamps - Scratch - Small / Roof - Scratch - Minimal</p>
