## General Information

| <b>Make</b> | Toyota | <b>Model</b> | Vios |
| <b>Registration No.</b> | CCC5486 | <b>Chassis No.</b> | PA1B18F34R4242385 |

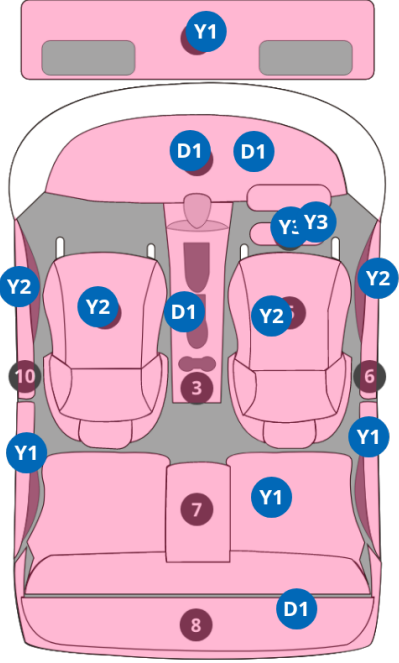
| <b>Interior Evaluation :</b> <span style="float: right; color: red; font-weight: bold;">C</span> | <b>Exterior Evaluation :</b> <span style="float: right; color: red; font-weight: bold;">E</span> |
| <b>Remarks</b><br>(R) Front Floor Mat - Grime - Medium / Mat Other - Grime - Medium / Rear Seat - Grime - Minimal / Dashboard - Worked - Minimal / (L) Front Trim - Grime - Small / (R) Front Trim - Grime - Small / (L) Front Seat - Grime - Small / (R) Front Seat - Grime - Small / Console, Switchs, Vents - Worked - Minimal / Trunk Room - Worked - Minimal / Ceiling - Grime - Minimal / (R) Rear Trim - Grime - Minimal / (L) Rear Trim - Grime - Minimal | <b>Remarks</b><br>(R) Front Fender - Repair Traces - Yes / (L) Front Fender, Molding - Scratch & Dent - Minimal / (L) Front Door, Molding - Scratch & Dent - Medium / (L) Step, In-panel, Side Spoiler - Scratch & Dent - Minimal / (L) Rear Door, Molding - Scratch - Medium / (L) Rear Fender, Molding - Scratch - Medium / Rear Bumper, Lamps, Panels - Scratch - Medium / Trunk Hood, Rear Gate - Scratch & Dent - Small / Roof - Dent - Small / (R) Rear Fender, Molding - Scratch & Dent - Small / (R) Rear Door, Molding - Scratch - Medium / (R) Front Door, Molding - Scratch & Dent - Small / (R) Front Fender, Molding - Scratch - Small / Bonnet, Headlight - Scratch & Dent - Small / (R) Step, In-panel, Side Spoiler - Scratch & Dent - Small / Front Bumper, Grille, Lamps - Scratch & Dent - Small |

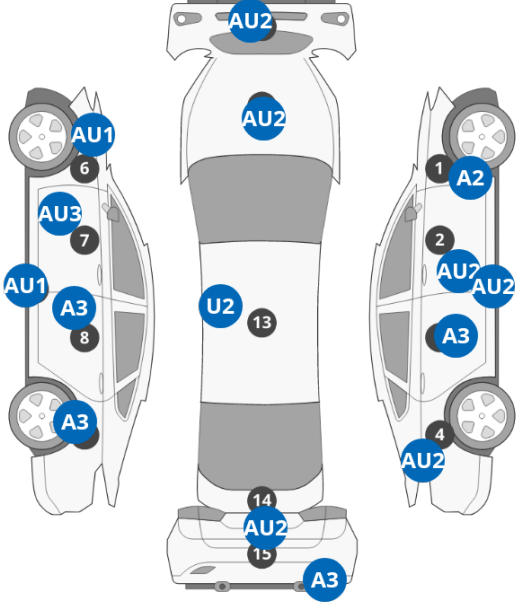
| with spare tire, spare key, with spare tire, with incomplete tools & jack, no warranty & manual booklet, no reverse camera, scratches on taillight, no LTO plate. |
