General Information

Make	Toyota	Model	Vios
YOM	2022	Odo Meter Reading	86,404
Registration No.	DAQ8953	Chassis No.	PA1B18F37N4180491
CC	1.3	Transmission	CVT
Fuel Type	Gas	Type of Body	Sedan
Colour	Blue

Body / Panel Condition

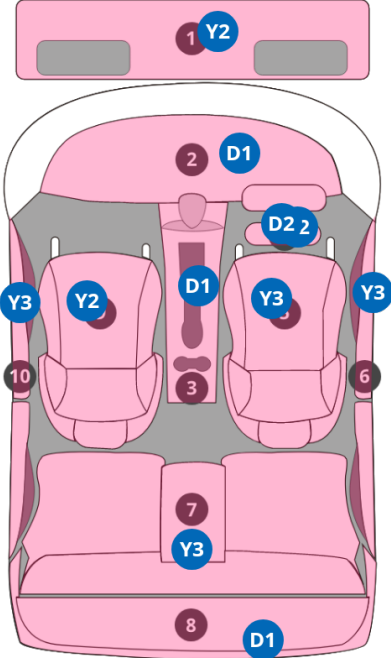
Interior Evaluation : C	Exterior Evaluation : E

<p>a : Cut, Fray d : Loose, Deformed k : Animal Hair s : Smell t : Cigarette Burns x : Defective y : Stain</p>

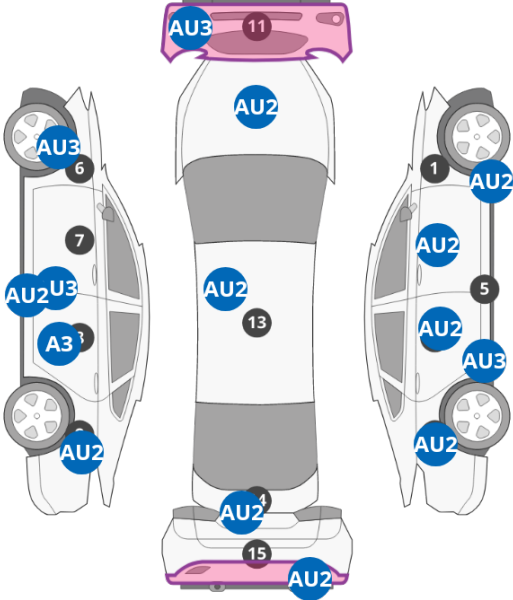
<p>A : Scratch AU : Scratch & Dent B : Modified C : Corrosion G : Stone chip P : Faded S : Rust SC : Rust & Corrosion U : Dent X : Defective Y : Crack, Gap</p>
<p>Remarks (R) Front Trim - Grime - Medium / Rear Seat - Grime - Medium / (R) Front Seat - Grime - Medium / (L) Front Trim - Grime - Medium / Trunk Room - Worked - Minimal / Ceiling - Grime - Small / (R) Front Floor Mat - Grime - Small / (L) Front Floor Mat - Worked - Small / Dashboard - Worked - Minimal / (L) Front Seat - Grime - Small / Console, Switchs, Vents - Worked - Minimal</p>	<p>Remarks (L) Step - Repair Traces - Yes / (L) Front Fender, Molding - Scratch & Dent - Medium / Bonnet, Headlight - Scratch & Dent - Small / Roof - Scratch & Dent - Small / (L) Front Door, Molding - Scratch & Dent - Medium / (L) Rear Door, Molding - Scratch - Medium / (L) Step, In-panel, Side Spoiler - Scratch & Dent - Small / (L) Rear Fender, Molding - Scratch & Dent - Small / (R) Rear Fender, Molding - Scratch & Dent - Small / Rear Bumper, Lamps, Panels - Scratch & Dent - Small / (R) Step, In-panel, Side Spoiler - Scratch & Dent - Medium / (R) Rear Door, Molding - Scratch & Dent - Small / (R) Front Door, Molding - Scratch & Dent - Small / (R) Front Fender, Molding - Scratch & Dent - Small / Front Bumper, Grille, Lamps - Scratch & Dent - Medium / Trunk Hood, Rear Gate - Scratch & Dent - Small / Front Bumper, Grille, Lamps - Repair mark - Yes / Rear Bumper, Lamps, Panels - Repair mark - Yes</p>
