General Information

Make	Toyota	Model	Vios
YOM	2023	Odo Meter Reading	27,627
Registration No.	DBJ5601	Chassis No.	PA1B18F38P4224324
CC	1.3	Transmission	CVT
Fuel Type	Gas	Type of Body	Sedan
Colour	Blue

Body / Panel Condition

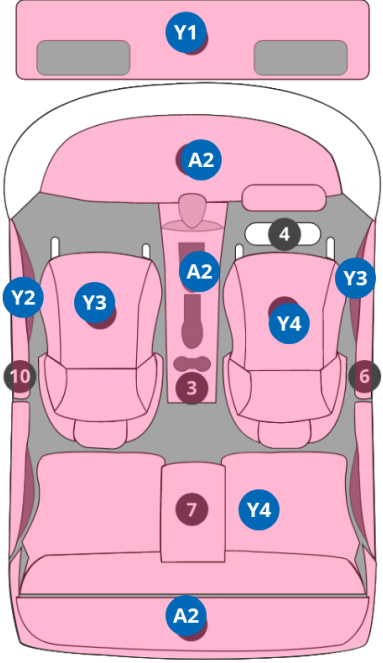
Interior Evaluation : C	Exterior Evaluation : D

<p>a : Cut, Fray d : Loose, Deformed k : Animal Hair s : Smell t : Cigarette Burns x : Defective y : Stain</p>

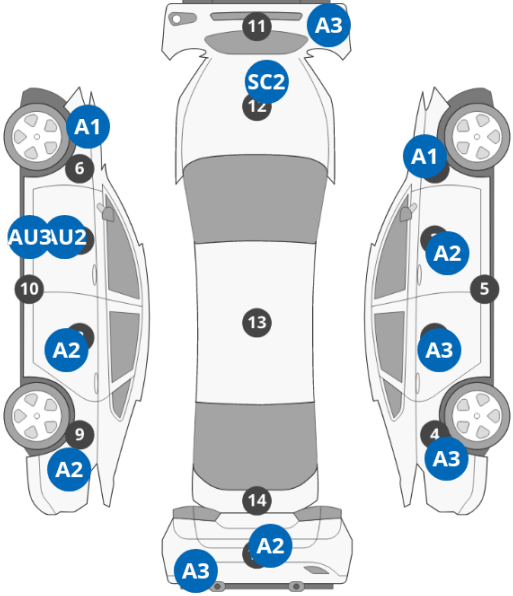
<p>A : Scratch AU : Scratch & Dent B : Modified C : Corrosion G : Stone chip P : Faded S : Rust SC : Rust & Corrosion U : Dent X : Defective Y : Crack, Gap</p>
<p>Remarks Rear Seat - Grime - Large / (R) Front Trim - Grime - Medium / (R) Front Seat - Grime - Large / (L) Front Trim - Grime - Small / (L) Front Seat - Grime - Medium / Ceiling - Grime - Minimal / Dashboard - Worn, Scratch, Cut, Crack - Small / Console, Switches, Vents - Worn, Scratch, Cut, Crack - Small / Trunk Room - Worn, Scratch, Cut, Crack - Small</p>	<p>Remarks (L) Front Door, Molding - Scratch & Dent - Small / (L) Rear Door, Molding - Scratch - Small / (L) Step, In-panel, Side Spoiler - Scratch & Dent - Medium / Bonnet, Headlight - Rust, Corrosion - Small / Front Bumper, Grille, Lamps - Scratch - Medium / (R) Front Fender, Molding - Scratch - Minimal / (R) Front Door, Molding - Scratch - Small / (R) Rear Door, Molding - Scratch - Medium / (R) Rear Fender, Molding - Scratch - Medium / Rear Bumper, Lamps, Panels - Scratch - Medium / Trunk Hood, Rear Gate - Scratch - Small / (L) Rear Fender, Molding - Scratch - Small / (L) Front Fender, Molding - Scratch - Minimal</p>
