General Information

Make	Toyota	Model	Vios
YOM	2022	Odo Meter Reading	11,084
Registration No.	NEL8572	Chassis No.	PA1B18F32M4165587
CC	1.3	Transmission	CVT
Fuel Type	Gas	Type of Body	Sedan
Colour	Red Mica Metallic

Body / Panel Condition

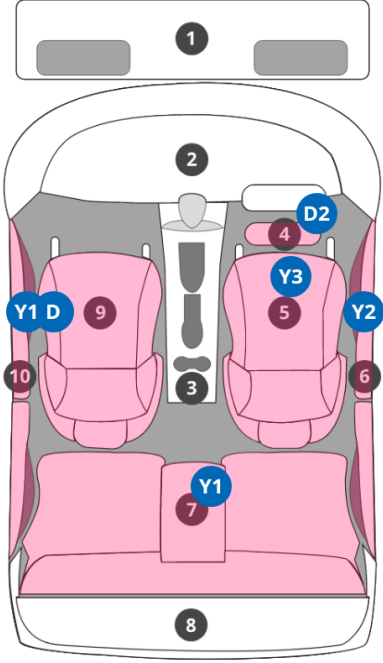
Interior Evaluation : B	Exterior Evaluation : D

<p>a : Cut, Fray d : Loose, Deformed k : Animal Hair s : Smell t : Cigarette Burns x : Defective y : Stain</p>

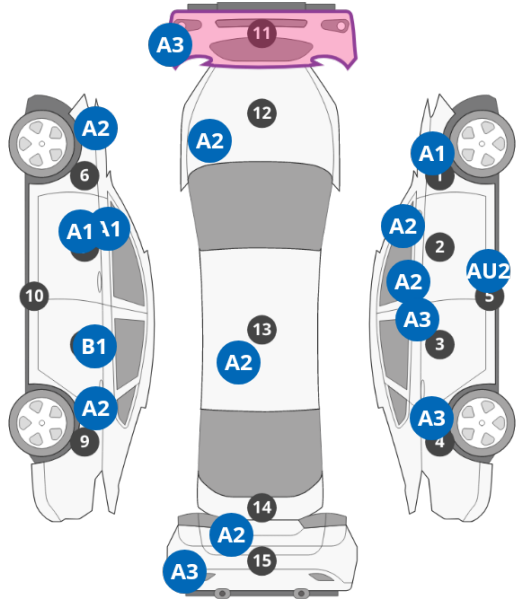
<p>A : Scratch AU : Scratch & Dent B : Modified C : Corrosion G : Stone chip P : Faded S : Rust SC : Rust & Corrosion U : Dent X : Defective Y : Crack, Gap</p>
<p>Remarks (L) Front Seat - Worn - Yes / (R) Front Seat - Grime - Medium / (L) Front Floor Mat - Worked - Small / (R) Front Trim - Grime - Small / (L) Front Trim - Grime - Minimal / Rear Seat - Grime - Minimal</p>	<p>Remarks (R) Front Fender - Repair Traces - Yes / (R) Front Fender, Molding - Scratch - Minimal / (R) Mirror - Scratch - Small / (R) Step, In-panel, Side Spoiler - Scratch & Dent - Small / (R) Front Door, Molding - Scratch - Small / (R) Rear Door, Molding - Scratch - Medium / (R) Rear Fender, Molding - Scratch - Medium / Rear Bumper, Lamps, Panels - Scratch - Medium / Trunk Hood, Rear Gate - Scratch - Small / (L) Rear Fender, Molding - Scratch - Small / (L) Rear Door, Molding - Modified - Minimal / (L) Mirror - Scratch - Minimal / (L) Front Door, Molding - Scratch - Minimal / (L) Front Fender, Molding - Scratch - Small / Front Bumper, Grille, Lamps - Repair mark - Yes / Front Bumper, Grille, Lamps - Scratch - Medium / Bonnet, Headlight - Scratch - Small / Roof - Scratch - Small</p>
