General Information

Make	Toyota	Model	Wigo
YOM	2022	Odo Meter Reading	40,762
Registration No.	NFI9365	Chassis No.	MHKA4DF5FMJ064135
CC	1.0	Transmission	A/T
Fuel Type	Gas	Type of Body	Hatchback
Colour	Gray

Body / Panel Condition

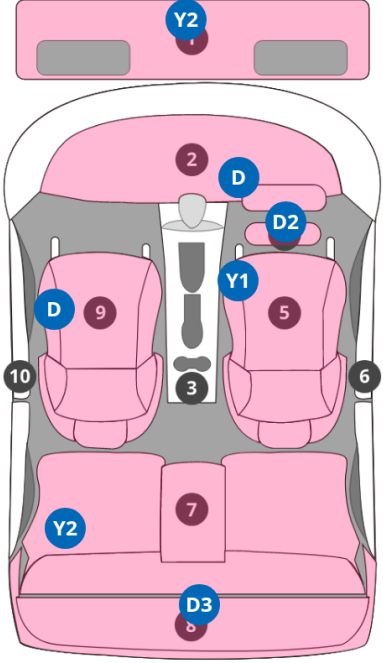
<p>a : Cut, Fray d : Loose, Deformed k : Animal Hair s : Smell t : Cigarette Burns x : Defective y : Stain</p>

<p>A : Scratch AU : Scratch & Dent B : Modified C : Corrosion G : Stone chip P : Faded S : Rust SC : Rust & Corrosion U : Dent X : Defective Y : Crack, Gap</p>
<p>Remarks (L) Front Floor Mat - Worked - Small / (L) Front Seat - Worn - Yes / Overall Interior - Worn as per age - Yes / Ceiling - Grime - Small / Trunk Room - Loose, Deformed - Medium / (R) Front Seat - Grime - Minimal / Rear Seat - Grime - Small / Dashboard - Traces of Adhesive Tape - Yes</p>	<p>Remarks (R) Rear Fender - Repair Traces - Yes / (R) Front Fender, Molding - Scratch - Small / (R) Mirror - Scratch - Small / (R) Step, In-panel, Side Spoiler - Scratch & Dent - Small / (R) Rear Door, Molding - Scratch - Large / (R) Front Door, Molding - Scratch - Small / Rear Bumper, Lamps, Panels - Crack, Gap - Medium / Trunk Hood, Rear Gate - Scratch - Small / (L) Rear Fender, Molding - Scratch & Dent - Medium / (L) Front Door, Molding - Scratch - Large / (L) Rear Door, Molding - Scratch - Large / (L) Step, In-panel, Side Spoiler - Scratch - Small / (L) Mirror - Scratch - Small / (L) Front Fender, Molding - Scratch - Small / Front Bumper, Grille, Lamps - Scratch & Dent - Medium / Bonnet, Headlight - Scratch - Small / Roof - Scratch & Dent - Small</p>

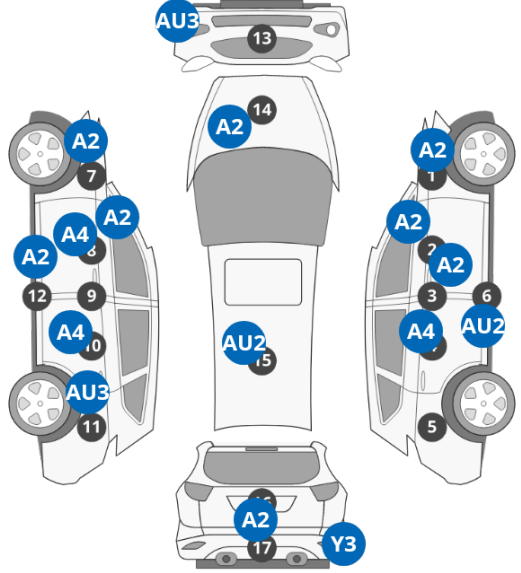
<p>Inspector Notes</p>
<p>no warranty booklet, jack and tools, no spare tire, with LTO plate, scratches on headlight and tail light, plate light issue, cracked tail light</p>
