General Information

Make	Toyota	Model	Vios
YOM	2024	Odo Meter Reading	2,884
Registration No.	NHH5778	Chassis No.	PA1B18F38R4240011
CC	1.3	Transmission	CVT
Fuel Type	Gas	Type of Body	Sedan
Colour	Red Mica Metallic

Body / Panel Condition

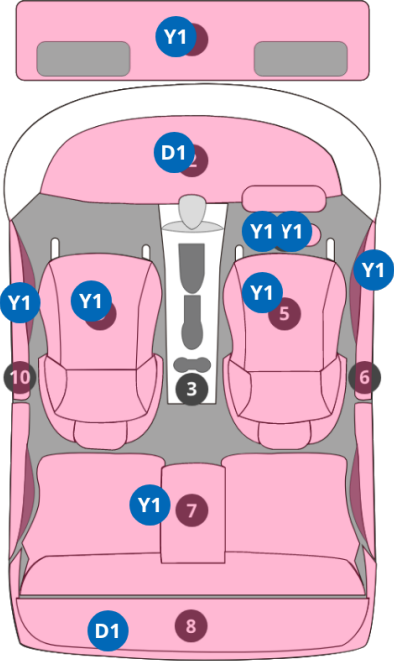
Interior Evaluation : A	Exterior Evaluation : C

<p>a : Cut, Fray d : Loose, Deformed k : Animal Hair s : Smell t : Cigarette Burns x : Defective y : Stain</p>

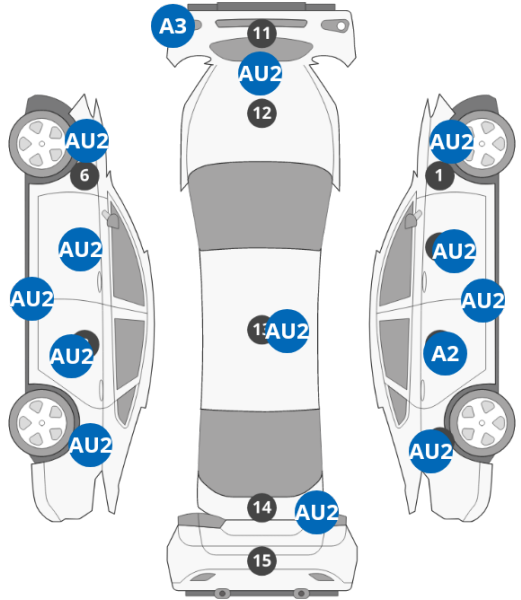
<p>A : Scratch AU : Scratch & Dent B : Modified C : Corrosion G : Stone chip P : Faded S : Rust SC : Rust & Corrosion U : Dent X : Defective Y : Crack, Gap</p>
<p>Remarks Dashboard - Worked - Minimal / (L) Front Seat - Grime - Minimal / Trunk Room - Worked - Minimal / (R) Front Seat - Grime - Minimal / (R) Front Trim - Grime - Minimal / (L) Front Trim - Grime - Minimal / Rear Seat - Grime - Minimal / (R) Front Floor Mat - Grime - Minimal / (L) Front Floor Mat - Grime - Minimal / Ceiling - Grime - Minimal</p>	<p>Remarks Bonnet, Headlight - Scratch & Dent - Small / Front Bumper, Grille, Lamps - Scratch - Medium / (L) Front Door, Molding - Scratch & Dent - Small / (L) Step, In-panel, Side Spoiler - Scratch & Dent - Small / (L) Rear Door, Molding - Scratch & Dent - Small / (L) Rear Fender, Molding - Scratch & Dent - Small / Trunk Hood, Rear Gate - Scratch & Dent - Small / (R) Rear Fender, Molding - Scratch & Dent - Small / (R) Step, In-panel, Side Spoiler - Scratch & Dent - Small / (R) Rear Door, Molding - Scratch - Small / Roof - Scratch & Dent - Small / (R) Front Door, Molding - Scratch & Dent - Small / (R) Front Fender, Molding - Scratch & Dent - Small / (L) Front Fender, Molding - Scratch & Dent - Small</p>
