General Information

Make	Toyota	Model	Vios
YOM	2024	Odo Meter Reading	1,666
Registration No.	NHQ6038	Chassis No.	PA1B18F30R4249219
CC	1.3	Transmission	CVT
Fuel Type	Gas	Type of Body	Sedan
Colour	Black

Body / Panel Condition

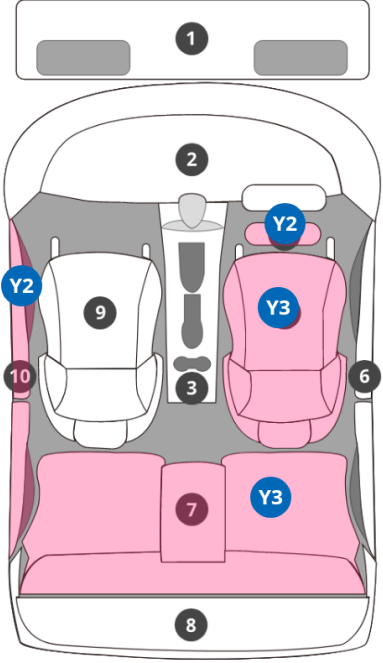
<p>a : Cut, Fray d : Loose, Deformed k : Animal Hair s : Smell t : Cigarette Burns x : Defective y : Stain</p>

<p>A : Scratch AU : Scratch & Dent B : Modified C : Corrosion G : Stone chip P : Faded S : Rust SC : Rust & Corrosion U : Dent X : Defective Y : Crack, Gap</p>
<p>Remarks Rear Seat - Grime - Medium / (R) Front Seat - Grime - Medium / (L) Front Trim - Grime - Small / (L) Front Floor Mat - Grime - Small</p>	<p>Remarks (L) Front Fender - Repair Traces - Yes / Trunk Hood, Rear Gate - Scratch - Minimal / (R) Mirror - Scratch - Minimal / (R) Front Door, Molding - Scratch - Small / (R) Rear Door, Molding - Scratch - Minimal / Bonnet, Headlight - Scratch - Small / (L) Front Fender, Molding - Repair mark - Yes / (L) Front Door, Molding - Scratch - Minimal / (L) Rear Fender, Molding - Scratch - Minimal / (L) Step, In-panel, Side Spoiler - Scratch - Large</p>
