General Information

Make	Toyota	Model	Vios
YOM	2021	Odo Meter Reading	100,849
Registration No.	VAA8183	Chassis No.	PA1B18F32L4125296
CC	1.3	Transmission	CVT
Fuel Type	Gas	Type of Body	Sedan
Colour	Red

Body / Panel Condition

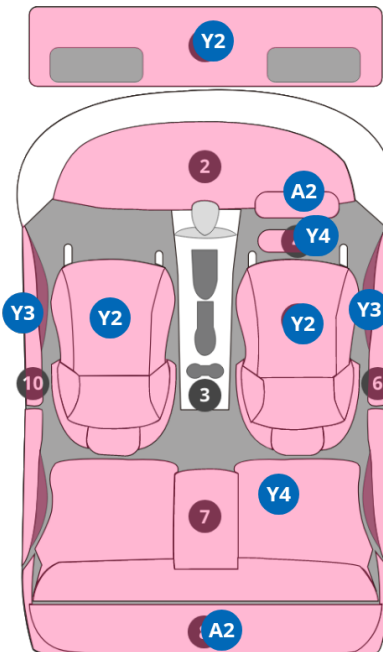
Interior Evaluation : D	Exterior Evaluation : E

<p>a : Cut, Fray d : Loose, Deformed k : Animal Hair s : Smell t : Cigarette Burns x : Defective y : Stain</p>

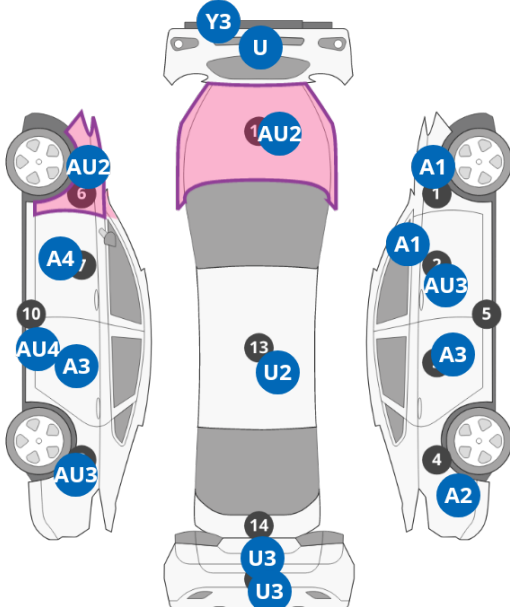
<p>A : Scratch AU : Scratch & Dent B : Modified C : Corrosion G : Stone chip P : Faded S : Rust SC : Rust & Corrosion U : Dent X : Defective Y : Crack, Gap</p>
<p>Remarks Rear Seat - Grime - Large / (R) Front Trim - Grime - Medium / (R) Front Seat - Grime - Small / (R) Front Floor Mat - Grime - Medium / Trunk Room - Worn, Scratch, Cut, Crack - Small / (L) Front Trim - Grime - Medium / (L) Front Floor Mat - Grime - Large / Ceiling - Grime - Small / Steering Wheel - Worn, Peel, Crack - Small / (L) Front Seat - Grime - Small</p>	<p>Remarks (R) Front Fender - Repair Traces - Yes / Bonnet - Repair Traces - Yes / (L) Front Fender - Repair Traces - Yes / Member (Bolted) - Dent - Yes / Trunk Hood, Rear Gate - Dent - Medium / Rear Bumper, Lamps, Panels - Dent - Medium / Roof - Dent - Small / (R) Rear Fender, Molding - Scratch - Small / (L) Front Fender, Molding - Repair mark - Yes / Bonnet, Headlight - Repair mark - Yes / (R) Rear Door, Molding - Scratch - Medium / (R) Front Door, Molding - Scratch & Dent - Medium / (R) Front Fender, Molding - Scratch - Minimal / (R) Mirror - Scratch - Minimal / Bonnet, Headlight - Scratch & Dent - Small / Front Bumper, Grille, Lamps - Crack, Gap - Medium / (L) Front Fender, Molding - Scratch & Dent - Small / (L) Front Door, Molding - Scratch - Large / (L) Step, In-panel, Side Spoiler - Scratch & Dent - Large / (L) Rear Door, Molding - Scratch - Medium / (L) Rear Fender, Molding - Scratch & Dent - Medium</p>
