General Information

Make	Toyota	Model	Avanza
YOM	2024	Odo Meter Reading	30,212
Registration No.	NFC9978	Chassis No.	MHFAA1BY0P0017177
CC	1.3	Transmission	M/T
Fuel Type	Gas	Type of Body	MPV
Colour	White

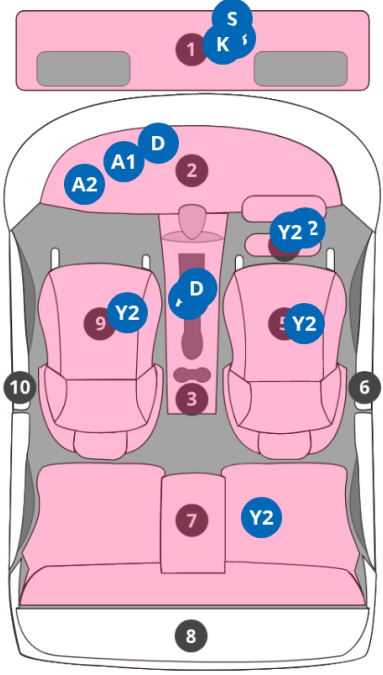
Interior Evaluation : C	Exterior Evaluation : E

<p>a : Cut, Fray d : Loose, Deformed k : Animal Hair s : Smell t : Cigarette Burns x : Defective y : Stain</p>

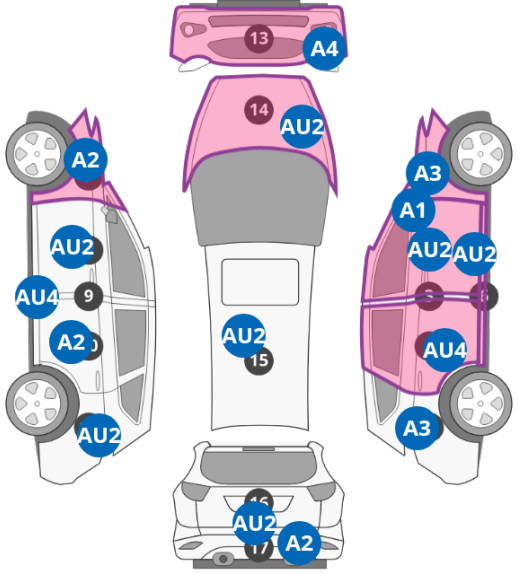
<p>A : Scratch AU : Scratch & Dent B : Modified C : Corrosion G : Stone chip P : Faded S : Rust SC : Rust & Corrosion U : Dent X : Defective Y : Crack, Gap</p>
<p>Remarks Ceiling - Grime - Medium / Overall Interior - Smell - Yes / Overall Interior - Animal Hair - Yes / (L) Front Floor Mat - Worked - Small / Mat Other - Grime - Small / (L) Front Seat - Grime - Small / Rear Seat - Grime - Small / Console, Switchs, Vents - Worn, Scratch, Cut, Crack - Small / Console, Switchs, Vents - Traces of Adhesive Tape - Yes / Dashboard - Traces of Adhesive Tape - Yes / Dashboard - Worn, Scratch, Cut, Crack - Minimal / Steering Wheel - Worn, Peel, Crack - Small / (R) Front Seat - Grime - Small</p>	<p>Remarks (R) Front Door - Repair Traces - Yes / (R) Step - Repair Traces - Yes / (R) Step - Replaced - Yes / (R) Front Fender - Repair Traces - Yes / Bonnet - Repair Traces - Yes / (L) Front Fender - Repair Traces - Yes / (R) Front Door, Molding - Repair mark - Yes / (R) Step, In-panel, Side Spoiler - Repair mark - Yes / (R) Front Fender, Molding - Repair mark - Yes / Bonnet, Headlight - Repair mark - Yes / (L) Front Fender, Molding - Repair mark - Yes / Front Bumper, Grille, Lamps - Repair mark - Yes / Front Bumper, Grille, Lamps - Scratch - Large / (R) Front Fender, Molding - Scratch - Medium / Bonnet, Headlight - Scratch & Dent - Small / (R) Front Door, Molding - Scratch & Dent - Small / (R) Mirror - Scratch - Minimal / (R) Step, In-panel, Side Spoiler - Scratch & Dent - Small / (R) Rear Door, Molding - Repair mark - Yes / (R) Rear Door, Molding - Scratch & Dent - Large / (R) Rear Fender, Molding - Scratch - Medium / Trunk Hood, Rear Gate - Scratch & Dent - Small / Rear Bumper, Lamps, Panels - Scratch - Small / (L) Rear Fender, Molding - Scratch & Dent - Small / (L) Rear Door, Molding - Scratch - Small / (L) Step, In-panel, Side Spoiler - Scratch & Dent - Large / (L) Front Door - Molding - Scratch & Dent - Small / (L) Front Fender, Molding - Scratch - Small / Roof - Scratch & Dent - Small</p>
