General Information

Make	Toyota	Model	Vios
YOM	2024	Odo Meter Reading	3,363
Registration No.	CAZ8645	Chassis No.	PA1B18F32R4238853
CC	1.3	Transmission	CVT
Fuel Type	Gas	Type of Body	Sedan
Colour	Silver

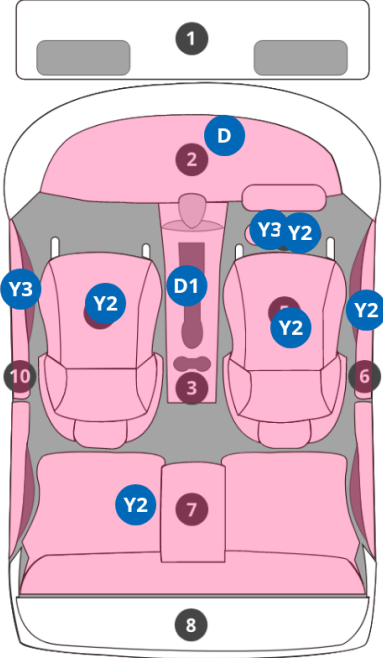
Interior Evaluation : C	Exterior Evaluation : C

<p>a : Cut, Fray d : Loose, Deformed k : Animal Hair s : Smell t : Cigarette Burns x : Defective y : Stain</p>

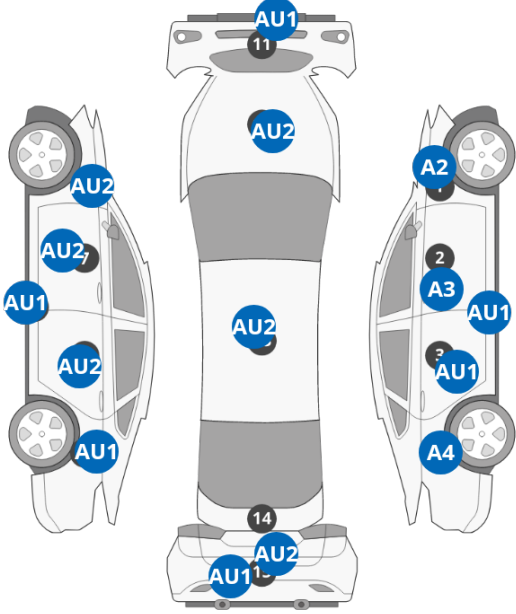
<p>A : Scratch AU : Scratch & Dent B : Modified C : Corrosion G : Stone chip P : Faded S : Rust SC : Rust & Corrosion U : Dent X : Defective Y : Crack, Gap</p>
<p>Remarks (R) Front Floor Mat - Grime - Medium / (L) Front Floor Mat - Grime - Small / Dashboard - Traces of Adhesive Tape - Yes / Console, Switchs, Vents - Worked - Minimal / (L) Front Trim - Grime - Medium / (R) Front Seat - Grime - Small / (L) Front Seat - Grime - Small / Rear Seat - Grime - Small / (R) Front Trim - Grime - Small</p>	<p>Remarks Roof - Scratch & Dent - Small / (L) Front Fender, Molding - Scratch & Dent - Small / (R) Front Fender, Molding - Scratch - Small / (R) Front Door, Molding - Scratch - Medium / (R) Step, In-panel, Side Spoiler - Scratch & Dent - Minimal / (R) Rear Door, Molding - Scratch & Dent - Minimal / (R) Rear Fender, Molding - Scratch - Large / Trunk Hood, Rear Gate - Scratch & Dent - Small / Rear Bumper, Lamps, Panels - Scratch & Dent - Minimal / (L) Rear Fender, Molding - Scratch & Dent - Minimal / (L) Step, In-panel, Side Spoiler - Scratch & Dent - Minimal / (L) Rear Door, Molding - Scratch & Dent - Small / (L) Front Door, Molding - Scratch & Dent - Small / Bonnet, Headlight - Scratch & Dent - Small / Front Bumper, Grille, Lamps - Scratch & Dent - Minimal</p>
