General Information

Make	Toyota	Model	Vios
YOM	2023	Odo Meter Reading	12,842
Registration No.	DBG7104	Chassis No.	PA1B18F36P4202547
CC	1.3	Transmission	CVT
Fuel Type	Gas	Type of Body	Sedan
Colour	Silver

Body / Panel Condition

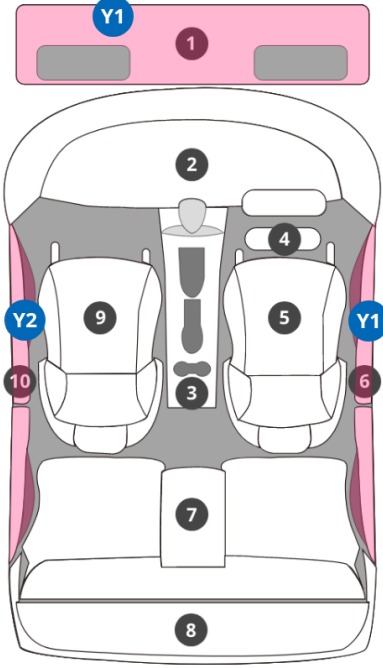
Interior Evaluation : A	Exterior Evaluation : B

<p>a : Cut, Fray d : Loose, Deformed k : Animal Hair s : Smell t : Cigarette Burns x : Defective y : Stain</p>

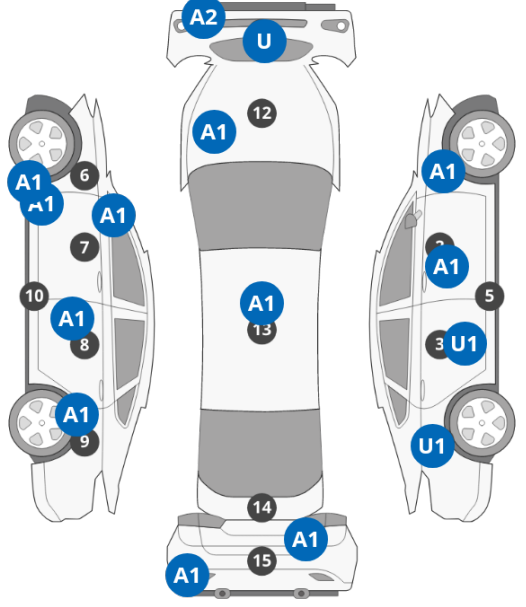
<p>A : Scratch AU : Scratch & Dent B : Modified C : Corrosion G : Stone chip P : Faded S : Rust SC : Rust & Corrosion U : Dent X : Defective Y : Crack, Gap</p>
<p>Remarks (R) Front Trim - Grime - Minimal / (L) Front Trim - Grime - Small / Ceiling - Grime - Minimal</p>	<p>Remarks (R) Front Fender, Molding - Scratch - Minimal / (R) Front Door, Molding - Scratch - Minimal / (R) Rear Door, Molding - Dent - Minimal / (R) Rear Fender, Molding - Dent - Minimal / Rear Bumper, Lamps, Panels - Scratch - Minimal / Trunk Hood, Rear Gate - Scratch - Minimal / (L) Rear Fender, Molding - Scratch - Minimal / (L) Rear Door, Molding - Scratch - Minimal / (L) Mirror - Scratch - Minimal / (L) Front Door, Molding - Scratch - Minimal / Member (Bolted) - Dent - Yes / (L) Front Fender, Molding - Scratch - Minimal / Front Bumper, Grille, Lamps - Scratch - Small / Bonnet, Headlight - Scratch - Minimal / Roof - Scratch - Minimal</p>
