General Information

Make	Toyota	Model	Vios
YOM	2024	Odo Meter Reading	1,499
Registration No.	NFR5392	Chassis No.	PA1B18F30R4248507
CC	1.3	Transmission	CVT
Fuel Type	Gas	Type of Body	Sedan
Colour	Silver

Body / Panel Condition

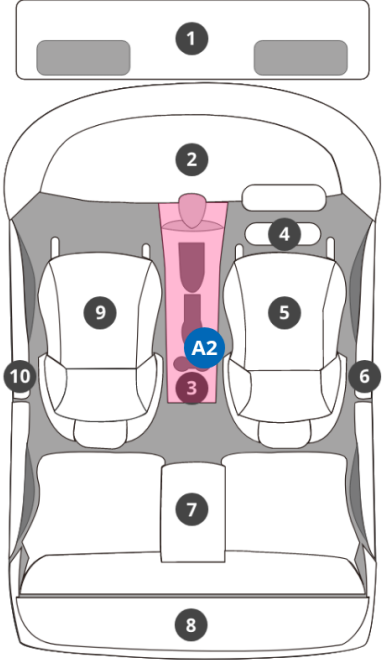
Interior Evaluation : A	Exterior Evaluation : C

<p>A : Scratch AU : Scratch & Dent B : Modified C : Corrosion G : Stone chip P : Faded S : Rust SC : Rust & Corrosion U : Dent X : Defective Y : Crack, Gap</p>
<p>Remarks Console, Switches, Vents - Worn, Scratch, Cut, Crack - Small</p>	<p>Remarks Rear Bumper, Lamps, Panels - Scratch - Large / Trunk Hood, Rear Gate - Scratch - Small / (R) Rear Door, Molding - Dent - Small / (L) Rear Door, Molding - Dent - Small / Front Bumper, Grille, Lamps - Scratch - Small / (L) Front Fender, Molding - Scratch - Minimal / (L) Front Door, Molding - Scratch - Minimal / (L) Rear Fender, Molding - Scratch - Small / (R) Rear Fender, Molding - Scratch - Minimal / (R) Front Door, Molding - Scratch - Minimal / Bonnet, Headlight - Scratch - Minimal</p>
