General Information

Make	Toyota	Model	Avanza
YOM	2025	Odo Meter Reading	24,079
Registration No.	NJA4452	Chassis No.	MHFAA1BY6R0037923
CC	1.3	Transmission	CVT
Fuel Type	Gas	Type of Body	MPV
Colour	Black

Body / Panel Condition

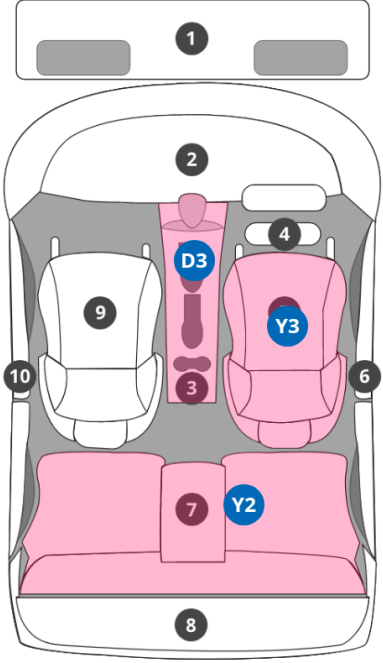
Interior Evaluation : B	Exterior Evaluation : C

<p>a : Cut, Fray d : Loose, Deformed k : Animal Hair s : Smell t : Cigarette Burns x : Defective y : Stain</p>

<p>A : Scratch AU : Scratch & Dent B : Modified C : Corrosion G : Stone chip P : Faded S : Rust SC : Rust & Corrosion U : Dent X : Defective Y : Crack, Gap</p>
<p>Remarks (R) Front Seat - Grime - Medium / Rear Seat - Grime - Small / Console, Switches, Vents - Loose, Deformed - Medium</p>	<p>Remarks (R) Front Door, Molding - Scratch - Minimal / (R) Rear Door, Molding - Scratch & Dent - Small / Rear Bumper, Lamps, Panels - Scratch & Dent - Large / Trunk Hood, Rear Gate - Scratch & Dent - Minimal / (L) Rear Fender, Molding - Scratch & Dent - Large / (L) Rear Door, Molding - Scratch & Dent - Large / (L) Front Door, Molding - Scratch - Minimal / Front Bumper, Grille, Lamps - Scratch & Dent - Medium / Bonnet, Headlight - Scratch - Minimal</p>

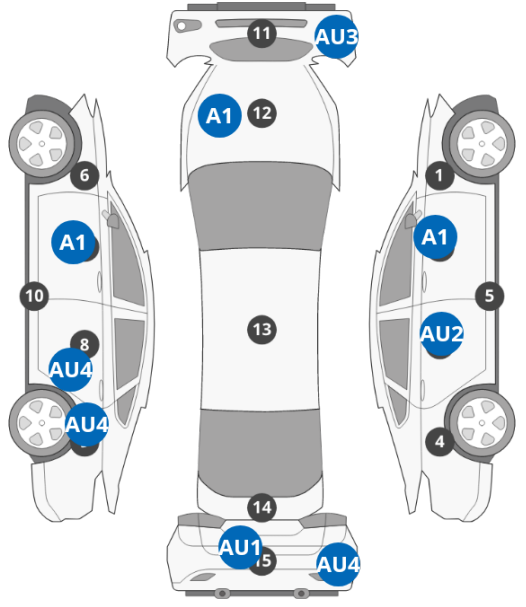
<p>Inspector Notes</p>
<p>With Lto plate, with warranty booklet, with spare tire and jack, 2keys, no tools, scratches on headlight, possible flooding, foul smell</p>
