## General Information

<b>Make</b>	Toyota	<b>Model</b>	Vios
<b>YOM</b>	2026	<b>Odo Meter Reading</b>	3,711
<b>Registration No.</b>	CDA4711	<b>Chassis No.</b>	PA1B18F31S4295227
<b>CC</b>	1.3	<b>Transmission</b>	CVT
<b>Fuel Type</b>	Gas	<b>Type of Body</b>	Sedan
<b>Colour</b>	Black

## Body / Panel Condition

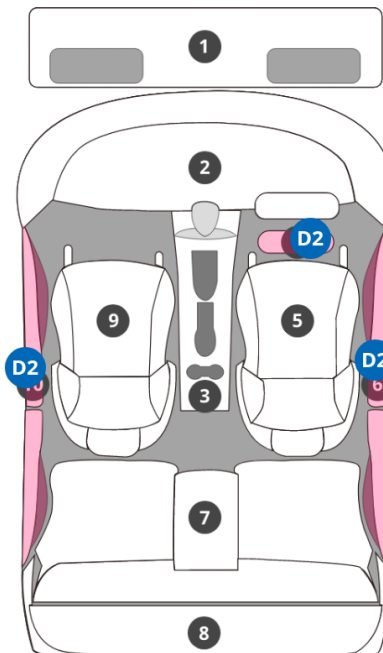
<b>Interior Evaluation :</b> <span style="float: right; color: red; font-weight: bold;">A</span>	<b>Exterior Evaluation :</b> <span style="float: right; color: red; font-weight: bold;">B</span>

<p><b>a</b> : Cut, Fray <b>d</b> : Loose, Deformed <b>k</b> : Animal Hair <b>s</b> : Smell <b>t</b> : Cigarette Burns <b>x</b> : Defective <b>y</b> : Stain</p>

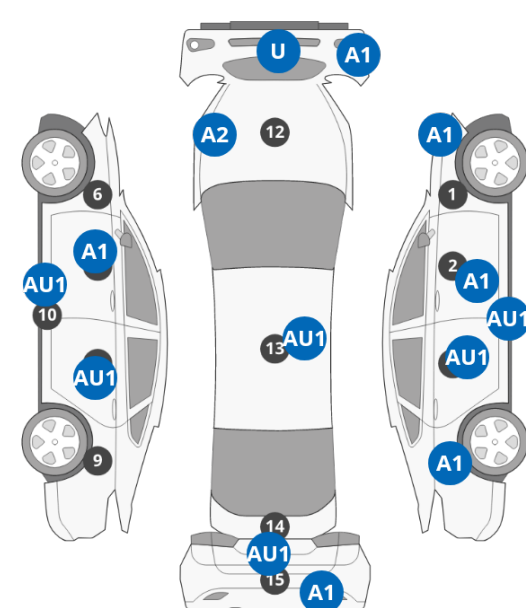
<p><b>A</b> : Scratch <b>AU</b> : Scratch &amp; Dent <b>B</b> : Modified <b>C</b> : Corrosion <b>G</b> : Stone chip <b>P</b> : Faded <b>S</b> : Rust <b>SC</b> : Rust &amp; Corrosion <b>U</b> : Dent <b>X</b> : Defective <b>Y</b> : Crack, Gap</p>
<p><b>Remarks</b> (L) Front Trim - Worked - Small / (L) Front Floor Mat - Worked - Small / (R) Front Trim - Worked - Small</p>	<p><b>Remarks</b> Member (Bolted) - Dent - Yes / Bonnet, Headlight - Scratch - Small / (L) Front Door, Molding - Scratch - Minimal / (L) Rear Door, Molding - Scratch &amp; Dent - Minimal / (L) Step, In-panel, Side Spoiler - Scratch &amp; Dent - Minimal / Rear Bumper, Lamps, Panels - Scratch - Minimal / Trunk Hood, Rear Gate - Scratch &amp; Dent - Minimal / (R) Rear Fender, Molding - Scratch - Minimal / (R) Rear Door, Molding - Scratch &amp; Dent - Minimal / (R) Front Door, Molding - Scratch - Minimal / (R) Front Fender, Molding - Scratch - Minimal / Roof - Scratch &amp; Dent - Minimal / (R) Step, In-panel, Side Spoiler - Scratch &amp; Dent - Minimal / Front Bumper, Grille, Lamps - Scratch - Minimal</p>

<p><b>Inspector Notes</b></p>
<p>With LTO plate and warranty booklet, No Sparetire and Jack and Tools, scratch headlight and tail light.</p>
