General Information

Make	Toyota	Model	Vios
YOM	2025	Odo Meter Reading	6,238
Registration No.	CCQ1179	Chassis No.	PA1B18F3XS4289488
CC	1.3	Transmission	CVT
Fuel Type	Gas	Type of Body	Sedan
Colour	Red

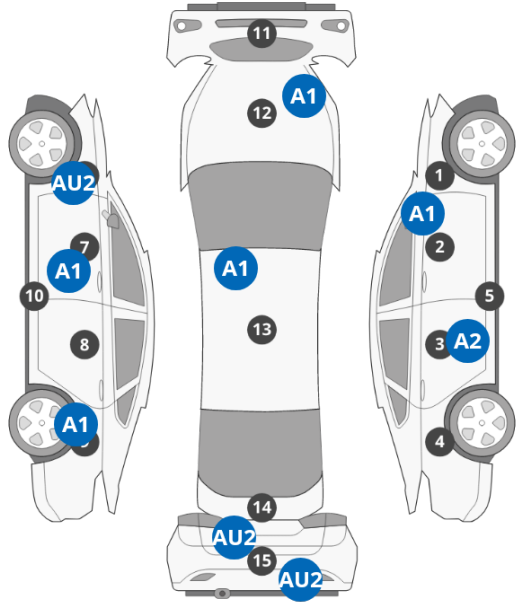
Interior Evaluation :	A	Exterior Evaluation :	B

<p>a : Cut, Fray d : Loose, Deformed k : Animal Hair s : Smell t : Cigarette Burns x : Defective y : Stain</p>		<p>A : Scratch AU : Scratch & Dent B : Modified C : Corrosion G : Stone chip P : Faded S : Rust SC : Rust & Corrosion U : Dent X : Defective Y : Crack, Gap</p>	
<p>Remarks Defects not found</p>		<p>Remarks (R) Mirror - Scratch - Minimal / (R) Rear Door, Molding - Scratch - Small / Rear Bumper, Lamps, Panels - Scratch & Dent - Small / Trunk Hood, Rear Gate - Scratch & Dent - Small / (L) Rear Fender, Molding - Scratch - Minimal / (L) Front Door, Molding - Scratch - Minimal / (L) Front Fender, Molding - Scratch & Dent - Small / Bonnet, Headlight - Scratch - Minimal / Roof - Scratch - Minimal</p>	
Frame Evaluation :	A	Functional Evaluation :	B
<p>Remarks Defects not found</p>		<p>Remarks Battery - Weak - Yes</p>

Inspector Notes
With Lto plate, with spare tire, 2keys, no warranty booklet, no jack and tools, scratches on headlight
