General Information

Make	Toyota	Model	Vios
YOM	2023	Odo Meter Reading	68,556
Registration No.	NIG6065	Chassis No.	PA1B18F36N4195998
CC	1.3	Transmission	CVT
Fuel Type	Gas	Type of Body	Sedan
Colour	Green

Body / Panel Condition

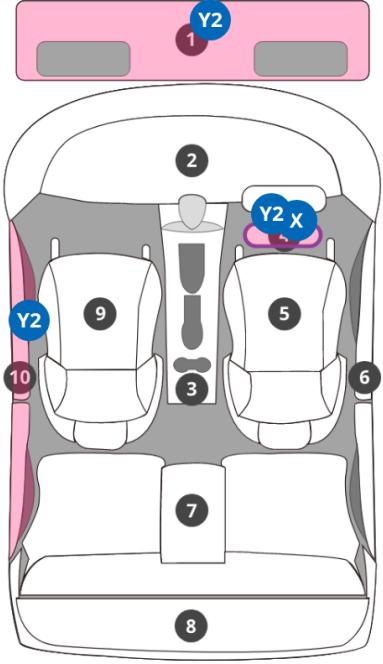
Interior Evaluation : B	Exterior Evaluation : E

<p>a : Cut, Fray d : Loose, Deformed k : Animal Hair s : Smell t : Cigarette Burns x : Defective y : Stain</p>

<p>A : Scratch AU : Scratch & Dent B : Modified C : Corrosion G : Stone chip P : Faded S : Rust SC : Rust & Corrosion U : Dent X : Defective Y : Crack, Gap</p>
<p>Remarks Mat Other - Missing - Yes / (L) Front Floor Mat - Grime - Small / (L) Front Trim - Grime - Small / Ceiling - Grime - Small</p>	<p>Remarks (R) Front Fender, Molding - Scratch & Dent - Large / (R) Front Door, Molding - Scratch & Dent - Medium / (R) Rear Door, Molding - Scratch & Dent - Large / (R) Step, In-panel, Side Spoiler - Scratch & Dent - Medium / (R) Rear Fender, Molding - Scratch & Dent - Medium / Rear Bumper, Lamps, Panels - Scratch & Dent - Large / (L) Rear Fender, Molding - Scratch & Dent - Large / Trunk Hood, Rear Gate - Scratch & Dent - Small / (L) Rear Door, Molding - Scratch - Small / (R) Mirror - Crack - Damaged / (L) Front Door, Molding - Scratch & Dent - Small / (L) Front Fender, Molding - Scratch - Minimal / Front Bumper, Grille, Lamps - Scratch & Dent - Large / Bonnet, Headlight - Scratch - Minimal</p>

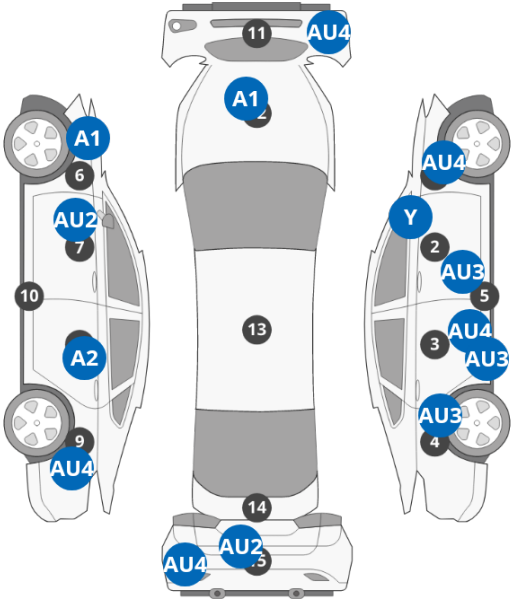
<p>Inspector Notes</p>
<p>With Lto plate, with warranty booklet, 1key, no spare tire, no jack and tools, scratches on headlights,</p>
