General Information

Make	Toyota	Model	Vios
YOM	2025	Odo Meter Reading	11,874
Registration No.	EAL1080	Chassis No.	PA1B18F33R4280772
CC	1.3	Transmission	CVT
Fuel Type	Gas	Type of Body	Sedan
Colour	Blue

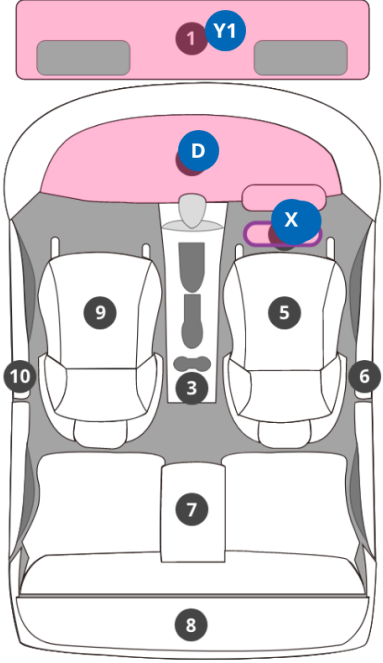
Interior Evaluation : B	Exterior Evaluation : B

<p>a : Cut, Fray d : Loose, Deformed k : Animal Hair s : Smell t : Cigarette Burns x : Defective y : Stain</p>

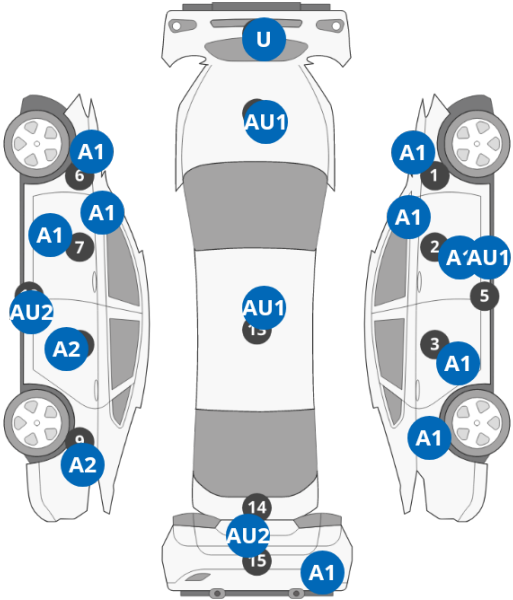
<p>A : Scratch AU : Scratch & Dent B : Modified C : Corrosion G : Stone chip P : Faded S : Rust SC : Rust & Corrosion U : Dent X : Defective Y : Crack, Gap</p>
<p>Remarks Mat Other - Missing - Yes / (L) Front Floor Mat - Missing - Yes / (R) Front Floor Mat - Missing - Yes / Dashboard - Traces of Adhesive Tape - Yes / Ceiling - Grime - Minimal</p>	<p>Remarks Member (Bolted) - Dent - Yes / (L) Front Fender, Molding - Scratch - Minimal / (L) Front Door, Molding - Scratch - Minimal / (L) Rear Door, Molding - Scratch - Small / (L) Step, In-panel, Side Spoiler - Scratch & Dent - Small / (L) Rear Fender, Molding - Scratch - Small / Trunk Hood, Rear Gate - Scratch & Dent - Small / Rear Bumper, Lamps, Panels - Scratch - Minimal / (R) Rear Fender, Molding - Scratch - Minimal / (R) Rear Door, Molding - Scratch - Minimal / (R) Front Door, Molding - Scratch - Minimal / (R) Step, In-panel, Side Spoiler - Scratch & Dent - Minimal / (R) Front Fender, Molding - Scratch - Minimal / Bonnet, Headlight - Scratch & Dent - Minimal / Roof - Scratch & Dent - Minimal / (R) Mirror - Scratch - Minimal / (L) Mirror - Scratch - Minimal</p>
