General Information

Make	Toyota	Model	Vios
YOM	2025	Odo Meter Reading	8,109
Registration No.	CCD5910	Chassis No.	PA1B18F36S4283879
CC	1.3	Transmission	CVT
Fuel Type	Gas	Type of Body	Sedan
Colour	Blue

Body / Panel Condition

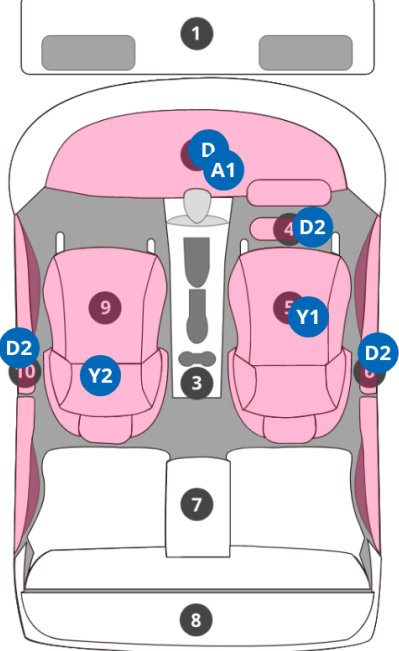
<p>a : Cut, Fray d : Loose, Deformed k : Animal Hair s : Smell t : Cigarette Burns x : Defective y : Stain</p>

<p>A : Scratch AU : Scratch & Dent B : Modified C : Corrosion G : Stone chip P : Faded S : Rust SC : Rust & Corrosion U : Dent X : Defective Y : Crack, Gap</p>
<p>Remarks (L) Front Floor Mat - Worked - Small / (L) Front Trim - Worked - Small / (R) Front Trim - Worked - Small / (L) Front Seat - Grime - Small / (R) Front Seat - Grime - Minimal / Dashboard - Traces of Adhesive Tape - Yes / Dashboard - Worn, Scratch, Cut, Crack - Minimal</p>	<p>Remarks Member (Bolted) - Dent - Yes / Bonnet, Headlight - Scratch & Dent - Small / (L) Front Fender, Molding - Scratch - Minimal / (L) Front Door, Molding - Scratch - Small / (L) Rear Door, Molding - Scratch & Dent - Minimal / (L) Step, In-panel, Side Spoiler - Scratch & Dent - Minimal / (L) Rear Fender, Molding - Scratch - Minimal / Trunk Hood, Rear Gate - Crack, Gap - Medium / Rear Bumper, Lamps, Panels - Crack, Gap - Medium / (R) Rear Fender, Molding - Scratch - Minimal / (R) Rear Door, Molding - Scratch & Dent - Minimal / (R) Front Door, Molding - Scratch - Minimal / (R) Step, In-panel, Side Spoiler - Scratch & Dent - Minimal / (R) Front Fender, Molding - Scratch - Minimal / Roof - Scratch - Small</p>
