## General Information

| Make | Toyota | Model | Avanza |
| Registration No. | GBK5091 | Chassis No. | MHFAA1BY1S0043523 |

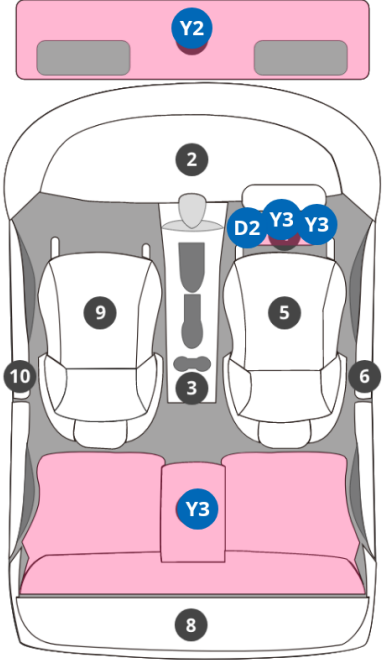
| Interior Evaluation : <b>B</b> | Exterior Evaluation : <b>C</b> |
| <p><b>Remarks</b><br/>Ceiling - Grime - Small / (R) Front Floor Mat - Grime - Medium / Mat Other - Grime - Medium / Rear Seat - Grime - Medium / (L) Front Floor Mat - Worked - Small</p> | <p><b>Remarks</b><br/>(L) Rear Door, Molding - Scratch - Small / (L) Rear Fender, Molding - Scratch - Small / (L) Front Door, Molding - Scratch - Small / Front Bumper, Grille, Lamps - Scratch - Small / (L) Front Fender, Molding - Scratch - Small / (R) Front Fender, Molding - Scratch - Small / (R) Mirror - Scratch - Minimal / (R) Front Door, Molding - Scratch - Small / (R) Rear Door, Molding - Scratch - Small / (R) Rear Fender, Molding - Scratch - Medium / Trunk Hood, Rear Gate - Scratch - Minimal / Rear Bumper, Lamps, Panels - Scratch - Small / Roof - Dent - Small</p> |
