## General Information

| Make | Toyota | Model | Vios |

## Body / Panel Condition

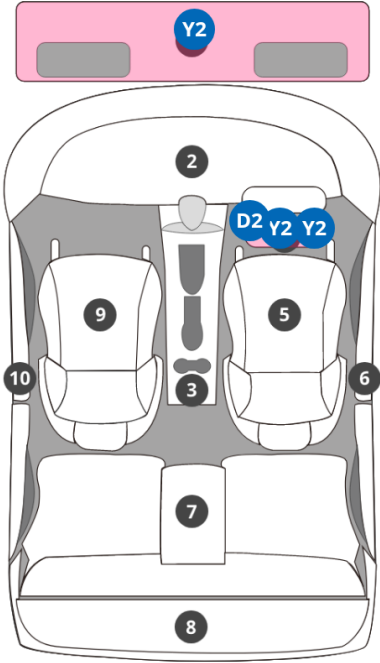
| Interior Evaluation : <span style="color: red; font-weight: bold;">A</span> | Exterior Evaluation : <span style="color: red; font-weight: bold;">E</span> |
| <p><b>Remarks</b></p> <p>Ceiling - Grime - Small / (R) Front Floor Mat - Grime - Small / Mat Other - Grime - Small / (L) Front Floor Mat - Worked - Small</p> | <p><b>Remarks</b></p> <p>Trunk Hood, Rear Gate - Scratch &amp; Dent - Small / Rear Bumper, Lamps, Panels - Scratch &amp; Dent - Medium / (L) Rear Fender, Molding - Scratch - Small / (L) Rear Door, Molding - Scratch - Small / (L) Front Door, Molding - Scratch - Small / (L) Mirror - Scratch - Small / (R) Front Fender, Molding - Scratch - Small / (R) Mirror - Scratch - Minimal / (R) Rear Door, Molding - Scratch - Small / (R) Front Door, Molding - Scratch - Small / (R) Rear Fender, Molding - Scratch - Medium / Bonnet, Headlight - Scratch - Small / Front Bumper, Grille, Lamps - Scratch &amp; Dent - Large / Front Windshield - Damaged - Large / Roof - Scratch &amp; Dent - Medium</p> |

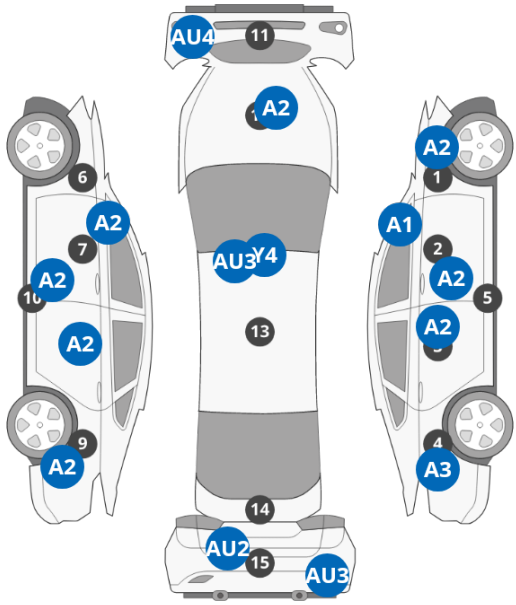
Damaged front windshield. Without warranty booklet. With spare tire, jack, tools and leather seat cover. 2 keys. With LTO plate.
