## General Information

| Make | Toyota | Model | Vios |
| Registration No. | FAJ5598 | Chassis No. | PA1B18F30N4179747 |

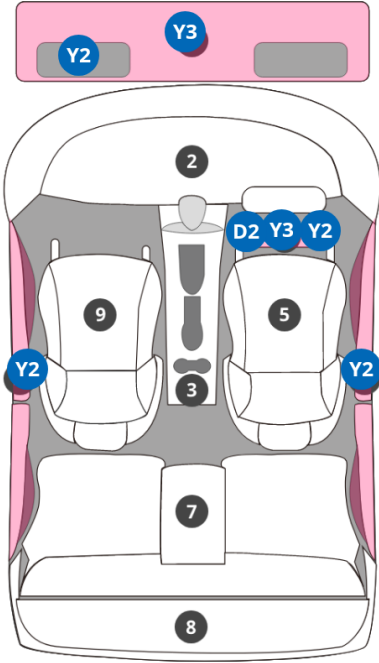
| Interior Evaluation : <b>B</b> | Exterior Evaluation : <b>E</b> |
|---|---|
| <p><b>Remarks</b><br/>Ceiling - Grime - Medium / Sunvisor, Sunglass Holder - Grime - Small / (R) Front Trim - Grime - Small / (R) Front Floor Mat - Grime - Small / Mat Other - Grime - Medium / (L) Front Trim - Grime - Small / (L) Front Floor Mat - Worked - Small</p> | <p><b>Remarks</b><br/>(R) Front Fender, Molding - Scratch &amp; Dent - Medium / (R) Mirror - Scratch - Minimal / (R) Front Door, Molding - Scratch - Small / (R) Step, In-panel, Side Spoiler - Scratch &amp; Dent - Medium / (R) Rear Door, Molding - Scratch - Small / (R) Rear Fender, Molding - Scratch - Small / Trunk Hood, Rear Gate - Scratch - Small / Rear Bumper, Lamps, Panels - Scratch &amp; Dent - Large / (L) Rear Fender, Molding - Scratch - Small / (L) Rear Door, Molding - Scratch - Small / (L) Front Door, Molding - Scratch - Small / (L) Mirror - Scratch - Small / Roof - Scratch - Small / (L) Front Fender, Molding - Scratch - Small / Bonnet, Headlight - Scratch &amp; Dent - Medium / Bonnet, Headlight - Repair mark - Yes / Front Bumper, Grille, Lamps - Scratch &amp; Dent - Large</p> |

| Inspector Notes |
|---|
| Hood repaired. Shifting not smooth. Without warranty booklet, spare tire, jack, and seat cover. Without tools. 1 key. With LTO plate. Crinkle at headliner. |
