## General Information

| Make | Toyota | Model | Vios |
| Registration No. | GBE2210 | Chassis No. | PA1B18F38R4246472 |

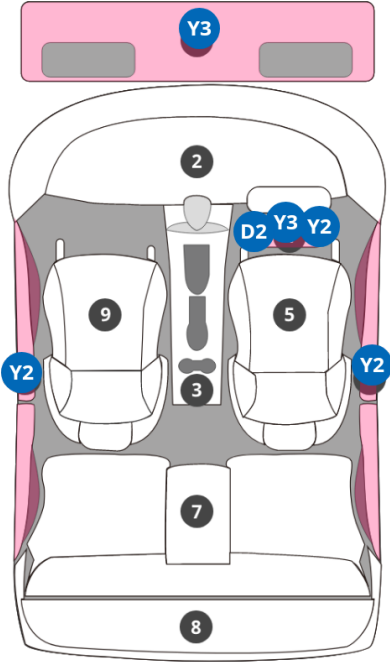
| Interior Evaluation : <b>B</b> | Exterior Evaluation : <b>C</b> |
|---|---|
| <b>Remarks</b><br>Ceiling - Grime - Medium / (R) Front Trim - Grime - Small / (R) Front Floor Mat - Grime - Small / Mat Other - Grime - Medium / (L) Front Trim - Grime - Small / (L) Front Floor Mat - Worked - Small | <b>Remarks</b><br>(L) Rear Fender, Molding - Dent - Medium / (L) Rear Door, Molding - Scratch - Small / (L) Mirror - Scratch - Minimal / (L) Front Door, Molding - Scratch - Minimal / (L) Front Fender, Molding - Scratch - Small / Bonnet, Headlight - Scratch - Small / Front Bumper, Grille, Lamps - Scratch & Dent - Small / (R) Front Fender, Molding - Scratch - Small / (R) Mirror - Scratch - Small / (R) Front Door, Molding - Scratch - Small / (R) Rear Door, Molding - Scratch - Small / (R) Rear Fender, Molding - Scratch & Dent - Small / Rear Bumper, Lamps, Panels - Scratch - Small / Trunk Hood, Rear Gate - Scratch - Small / Roof - Scratch - Small |
