General Information

Make	Toyota	Model	Vios
YOM	2024	Odo Meter Reading	33,023
Registration No.	GBE4697	Chassis No.	PA1B18F3XR4250880
CC	1.3	Transmission	CVT
Fuel Type	Gas	Type of Body	Sedan
Colour	Silver

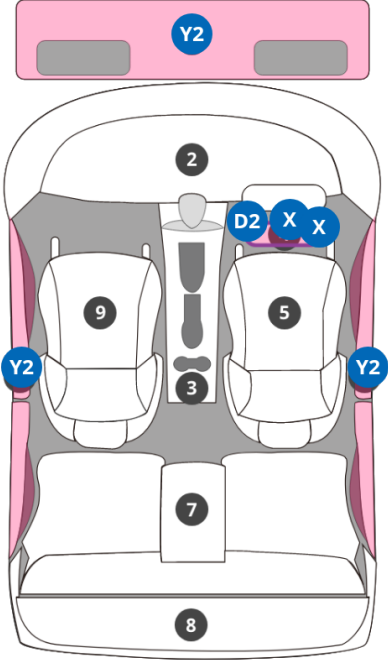
<p>a : Cut, Fray d : Loose, Deformed k : Animal Hair s : Smell t : Cigarette Burns x : Defective y : Stain</p>

<p>A : Scratch AU : Scratch & Dent B : Modified C : Corrosion G : Stone chip P : Faded S : Rust SC : Rust & Corrosion U : Dent X : Defective Y : Crack, Gap</p>
<p>Remarks Mat Other - Missing - Yes / (L) Front Trim - Grime - Small / (L) Front Floor Mat - Worked - Small / (R) Front Floor Mat - Missing - Yes / Ceiling - Grime - Small / (R) Front Trim - Grime - Small</p>	<p>Remarks (L) Mirror - Scratch - Small / (L) Rear Door, Molding - Scratch & Dent - Minimal / (L) Front Fender, Molding - Scratch - Small / (L) Rear Fender, Molding - Scratch - Minimal / Trunk Hood, Rear Gate - Scratch - Minimal / Rear Bumper, Lamps, Panels - Scratch - Small / (R) Rear Fender, Molding - Scratch & Dent - Medium / (R) Rear Door, Molding - Scratch & Dent - Large / (R) Front Door, Molding - Scratch - Small / (R) Front Fender, Molding - Scratch & Dent - Small / Bonnet, Headlight - Scratch - Small / Member (Bolted) - Dent - Yes / Front Bumper, Grille, Lamps - Scratch & Dent - Small</p>

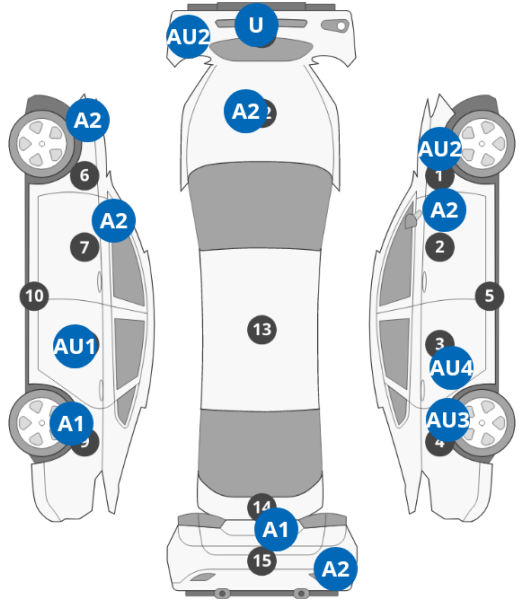
<p>Inspector Notes</p>
<p>Possible flooding. Gap at front bumper. Without warranty booklet, spare tire, jack and tools. With seat cover. 1 key. With LTO plate.</p>
