General Information

Make	Toyota	Model	Vios
YOM	2025	Odo Meter Reading	14,547
Registration No.	GBD7480	Chassis No.	PA1B18F35R4267490
CC	1.3	Transmission	CVT
Fuel Type	Gas	Type of Body	Sedan
Colour	Blackish Red Mica

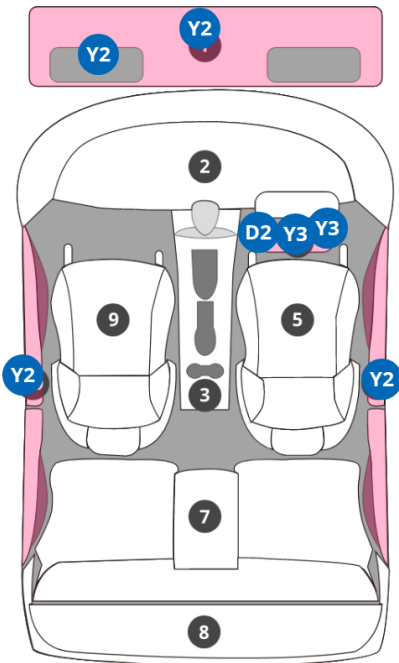
Interior Evaluation : B	Exterior Evaluation : E

<p>a : Cut, Fray d : Loose, Deformed k : Animal Hair s : Smell t : Cigarette Burns x : Defective y : Stain</p>

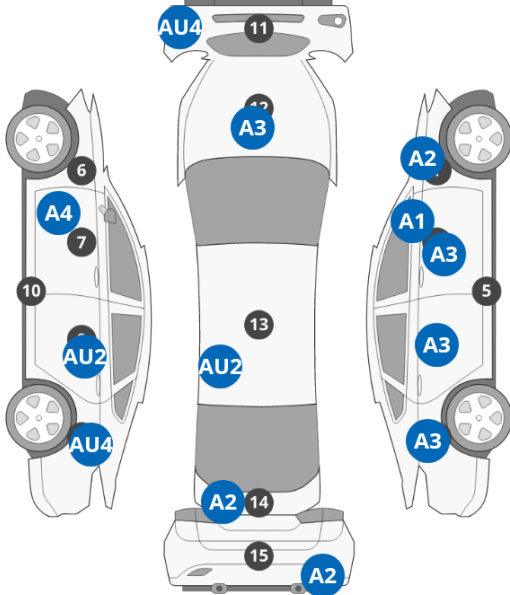
<p>A : Scratch AU : Scratch & Dent B : Modified C : Corrosion G : Stone chip P : Faded S : Rust SC : Rust & Corrosion U : Dent X : Defective Y : Crack, Gap</p>
<p>Remarks Ceiling - Grime - Small / Sunvisor, Sunglass Holder - Grime - Small / (R) Front Trim - Grime - Small / (R) Front Floor Mat - Grime - Medium / Mat Other - Grime - Medium / (L) Front Trim - Grime - Small / (L) Front Floor Mat - Worked - Small</p>	<p>Remarks (L) Rear Fender, Molding - Scratch & Dent - Large / (L) Rear Door, Molding - Scratch & Dent - Small / (L) Front Door, Molding - Scratch - Large / Bonnet, Headlight - Scratch - Medium / Front Bumper, Grille, Lamps - Scratch & Dent - Large / (R) Front Fender, Molding - Scratch - Small / (R) Mirror - Scratch - Minimal / (R) Front Door, Molding - Scratch - Medium / (R) Rear Door, Molding - Scratch - Medium / (R) Rear Fender, Molding - Scratch - Medium / Trunk Hood, Rear Gate - Scratch - Small / Rear Bumper, Lamps, Panels - Scratch - Small / Roof - Scratch & Dent - Small</p>
