## General Information

<b>Make</b>	Toyota	<b>Model</b>	Raize
<b>YOM</b>	2023	<b>Odo Meter Reading</b>	52,231
<b>Registration No.</b>	NHA3189	<b>Chassis No.</b>	MHKAA1BAP0PJ089852
<b>CC</b>	1.0	<b>Transmission</b>	A/T
<b>Fuel Type</b>	Gas	<b>Type of Body</b>	SUV
<b>Colour</b>	White

## Body / Panel Condition

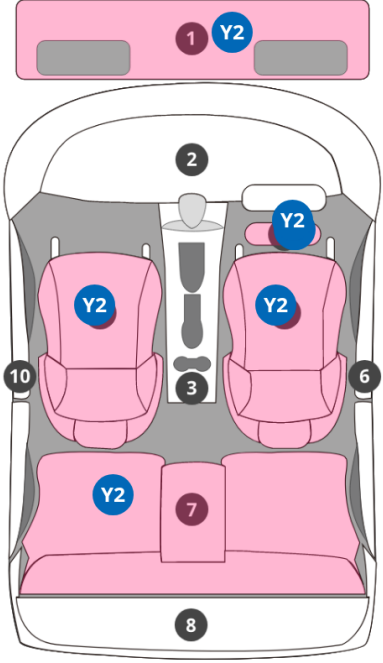
<b>Interior Evaluation :</b> <span style="float: right; color: red; font-weight: bold;">B</span>	<b>Exterior Evaluation :</b> <span style="float: right; color: red; font-weight: bold;">C</span>

<p><b>a</b> : Cut, Fray <b>d</b> : Loose, Deformed <b>k</b> : Animal Hair <b>s</b> : Smell <b>t</b> : Cigarette Burns <b>x</b> : Defective <b>y</b> : Stain</p>

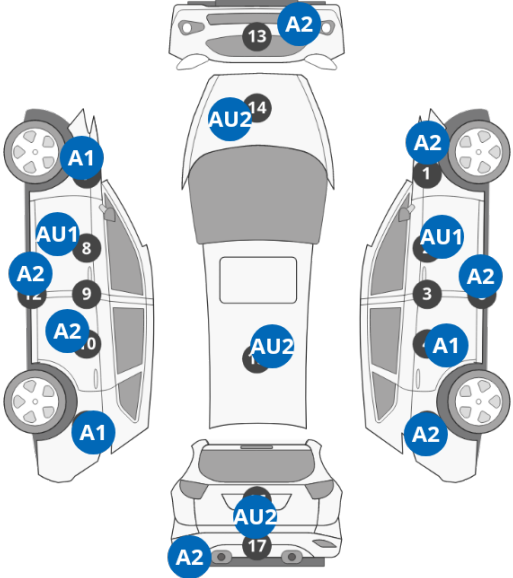
<p><b>A</b> : Scratch <b>AU</b> : Scratch &amp; Dent <b>B</b> : Modified <b>C</b> : Corrosion <b>G</b> : Stone chip <b>P</b> : Faded <b>S</b> : Rust <b>SC</b> : Rust &amp; Corrosion <b>U</b> : Dent <b>X</b> : Defective <b>Y</b> : Crack, Gap</p>
<b>Remarks</b> (L) Front Floor Mat - Grime - Small / (R) Front Floor Mat - Grime - Minimal / Mat Other - Grime - Small / Rear Seat - Grime - Small / (R) Front Seat - Grime - Small / (L) Front Seat - Grime - Small / Ceiling - Grime - Small	<b>Remarks</b> (L) Step, In-panel, Side Spoiler - Scratch - Small / (L) Front Door, Molding - Scratch & Dent - Minimal / (L) Rear Door, Molding - Scratch - Small / (L) Rear Fender, Molding - Scratch - Minimal / Bonnet, Headlight - Scratch & Dent - Small / Front Bumper, Grille, Lamps - Scratch - Small / (R) Front Fender, Molding - Scratch - Small / (R) Front Door, Molding - Scratch & Dent - Minimal / (R) Rear Door, Molding - Scratch - Minimal / (R) Step, In-panel, Side Spoiler - Scratch - Small / (R) Rear Fender, Molding - Scratch - Small / Trunk Hood, Rear Gate - Scratch & Dent - Small / Rear Bumper, Lamps, Panels - Scratch - Small / Roof - Scratch & Dent - Small / (L) Front Fender, Molding - Scratch - Minimal
