General Information

Make	Toyota	Model	Hiace
YOM	2025	Odo Meter Reading	40,355
Registration No.	BAH2229	Chassis No.	JTNAFAP3S8053062
CC	2.8	Transmission	M/T
Fuel Type	Diesel	Type of Body	Van
Colour	White

Body / Panel Condition

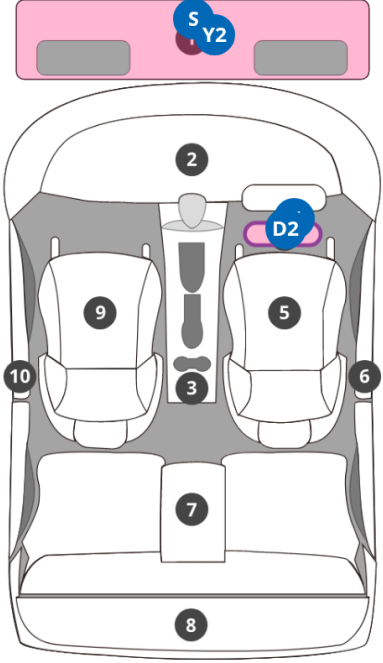
Interior Evaluation : B	Exterior Evaluation : E

<p>a : Cut, Fray d : Loose, Deformed k : Animal Hair s : Smell t : Cigarette Burns x : Defective y : Stain</p>

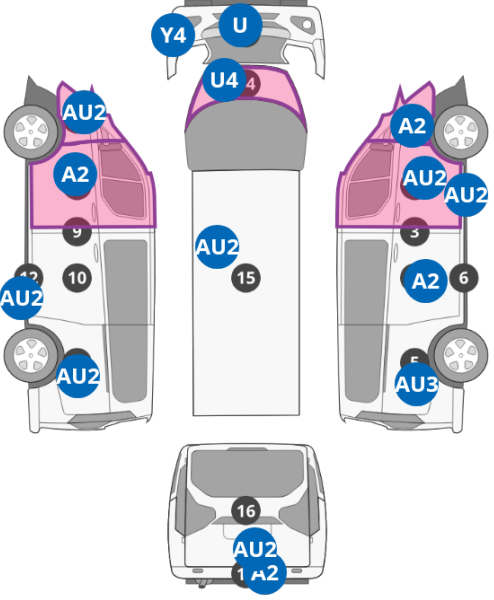
<p>A : Scratch AU : Scratch & Dent B : Modified C : Corrosion G : Stone chip P : Faded S : Rust SC : Rust & Corrosion U : Dent X : Defective Y : Crack, Gap</p>
Remarks Mat Other - Missing - Yes / (L) Front Floor Mat - Worked - Small / Overall Interior - Smell - Yes / Ceiling - Grime - Small	Remarks (R) Front Fender - Repair Traces - Yes / Bonnet - Repair Traces - Yes / (L) Front Fender - Repair Traces - Yes / (L) Front Door - Repair Traces - Yes / Front Bumper, Grille, Lamps - Crack, Gap - Large / (L) Front Door, Molding - Repair mark - Yes / (R) Front Door, Molding - Repair mark - Yes / (R) Front Fender, Molding - Repair mark - Yes / Bonnet, Headlight - Repair mark - Yes / (L) Front Fender, Molding - Repair mark - Yes / Member (Bolted) - Dent - Yes / Bonnet, Headlight - Dent - Large / (R) Front Fender, Molding - Scratch - Small / (R) Front Door, Molding - Scratch & Dent - Small / (R) Rear Door, Molding - Scratch - Small / (R) Step, In-panel, Side Spoiler - Scratch & Dent - Small / (R) Rear Fender, Molding - Scratch & Dent - Medium / Rear Bumper, Lamps, Panels - Scratch - Small / Trunk Hood, Rear Gate - Scratch & Dent - Small / (L) Step, In-panel, Side Spoiler - Scratch & Dent - Small / (L) Rear Fender, Molding - Scratch & Dent - Small / (L) Front Door, Molding - Scratch - Small / (L) Front Fender, Molding - Scratch & Dent - Small / Roof - Scratch & Dent - Small
