General Information

Make	Toyota	Model	Lite Ace
YOM	2025	Odo Meter Reading	38,639
Registration No.	CCG6659	Chassis No.	MHKU3FE10RK008962
CC	1.5	Transmission	M/T
Fuel Type	Gas	Type of Body	Utility Passenger
Colour	White

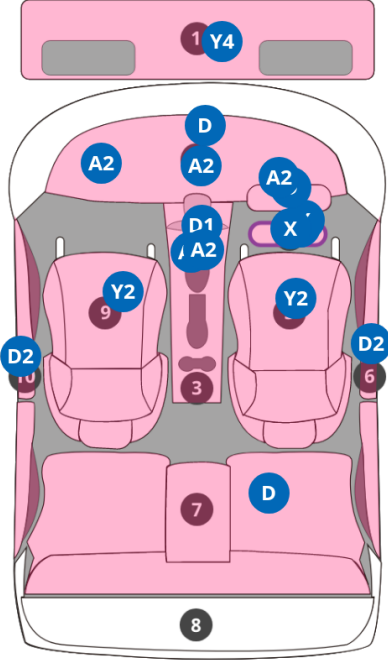
<p>a : Cut, Fray d : Loose, Deformed k : Animal Hair s : Smell t : Cigarette Burns x : Defective y : Stain</p>

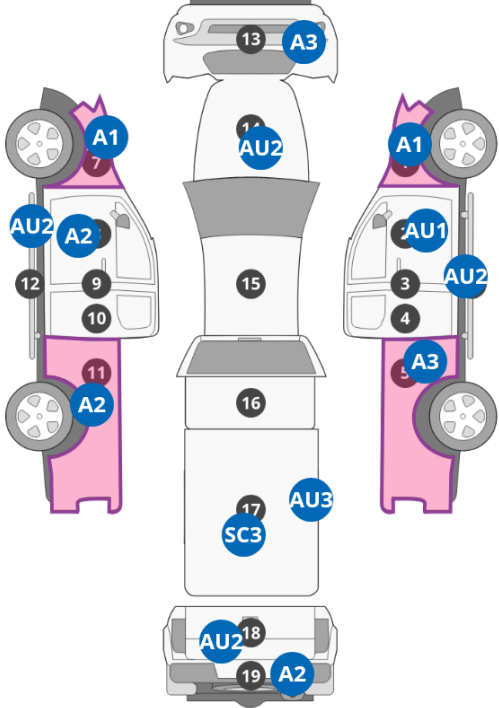
<p>A : Scratch AU : Scratch & Dent B : Modified C : Corrosion G : Stone chip P : Faded S : Rust SC : Rust & Corrosion U : Dent X : Defective Y : Crack, Gap</p>
<p>Remarks (L) Front Floor Mat - Missing - Yes / (R) Front Floor Mat - Missing - Yes / Mat Other - Missing - Yes / (L) Front Seat - Grime - Small / (R) Front Seat - Grime - Small / Dashboard - Traces of Adhesive Tape - Yes / Dashboard - Worn, Scratch, Cut, Crack - Small / Steering Wheel - Worn, Peel, Crack - Small / Glove Box - Traces of Adhesive Tape - Yes / Glove Box - Worn, Scratch, Cut, Crack - Small / Ceiling - Grime - Large / Rear Seat - Worn - Yes / Console, Switches, Vents - Worn, Scratch, Cut, Crack - Small / Console, Switches, Vents - Worked - Minimal / Knobs - Worn, Peel, Crack - Small / (L) Front Trim - Worked - Small / (R) Front Trim - Worked - Small</p>	<p>Remarks (L) Rear Corner Panel - Repair Traces - Yes / Front Bumper, Grille, Lamps - Scratch - Medium / (R) Side Gate - Repair mark - Yes / (R) Front Door, Molding - Scratch & Dent - Minimal / (R) Front Fender, Molding - Scratch - Minimal / (R) Side Gate - Scratch - Medium / (R) Front Wheel, Cover - Cap Missing - Yes / (R) Rear Wheel, Cover - Cap Missing - Yes / (L) Rear Wheel, Cover - Cap Missing - Yes / (L) Front Wheel, Cover - Cap Missing - Yes / Roof - Scratch & Dent - Medium / Rear Bumper, Lamps, Panels - Scratch - Small / Rear Gate - Scratch & Dent - Small / (L) Side Gate - Scratch - Small / (L) Front Door, Molding - Scratch - Small / (L) Front Fender, Molding - Scratch - Minimal / Bonnet, Headlight - Scratch & Dent - Small / (L) Step, In-panel, Side Spoiler - Scratch & Dent - Small / (R) Step, In-panel, Side Spoiler - Scratch & Dent - Small / Cargo Bed Floor - Rust, Corrosion - Medium</p>
